HOME INSPECTION REPORT

Date: 10/6/2020	Time: 08:30:00 AM	Report ID: 201006-31635
Property: 938 Doris Dr Encinitas CA 92024	Client: Tom White	Real Estate Professional: The Caspersen Brothers
Inspector: Brian Pennington	Support Phone: (760) 203-9682	Website: www.sdinspect.com

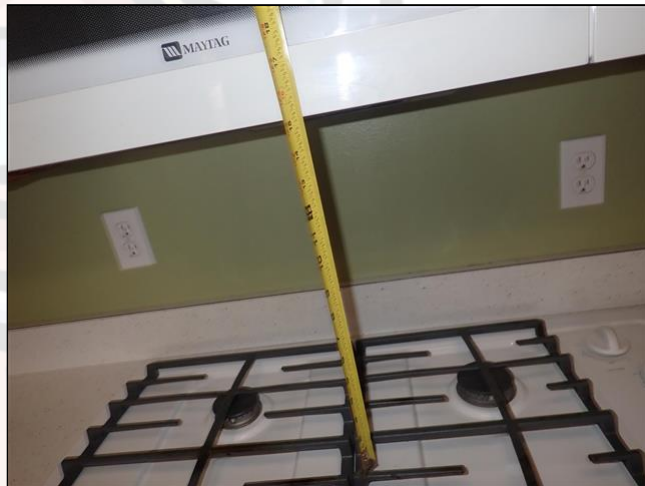
1.4 Picture

(1) The microwave was installed close to the cooktop surface. (less than 18" clearance between cooktop and bottom of microwave) This can cause damage to the plastic covering and the electronic control panel due to excessive heat. Also, this can be a hazard if the burner controls are located behind the cooking surface. We recommend checking the microwave manufacturers clearance requirements and relocating if a greater clearance is recommended.

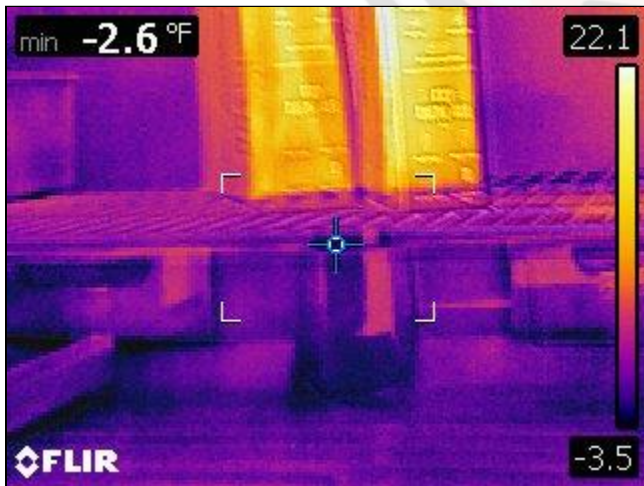
1.6 Picture

(1) The interior temperatures of refrigerator and freezer were observed using a thermal camera and the refrigerator appeared to be functional. This is not an exhaustive test and does not verify the efficiency of the refrigerator. Appliances are not moved to inspect the walls/floors/other components behind them. We recommend that you keep a good home warranty in place which covers the appliances.

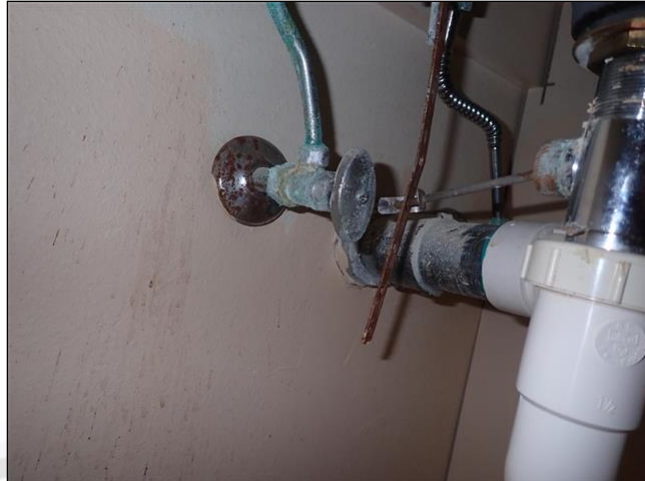
2.1 Picture

(1) One piece valve/flexible supply lines are installed at master bathroom sink. These supply pipes are known to corrode from the inside and fail. Corrosion/ calcification was observed at these valves which indicates that corrosion is taking place. We recommend replacing all of these older angle stop valves with new valves and braided steel supply lines to avoid leaks.

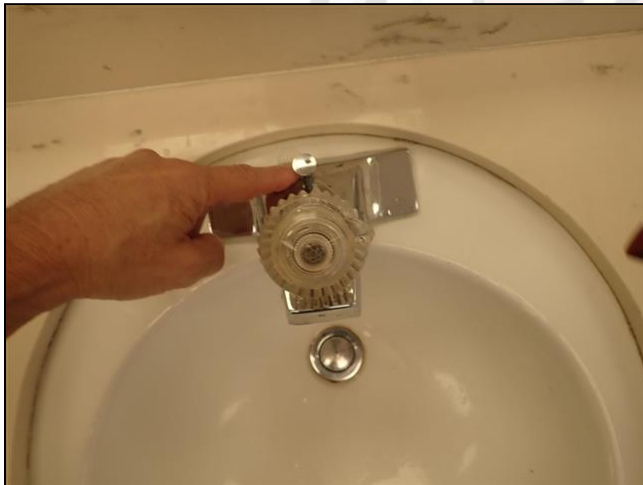
2.1 Picture

(2) The Master Bathroom and hall bathroom sink stopper is inoperable. We recommend necessary corrections.

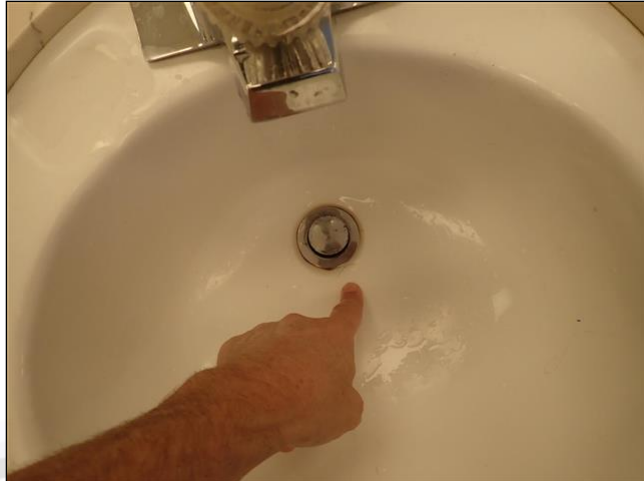
2.1 Picture

(3) The sink in the Master Bathroom is cracked. We recommend replacement to avoid leaks.

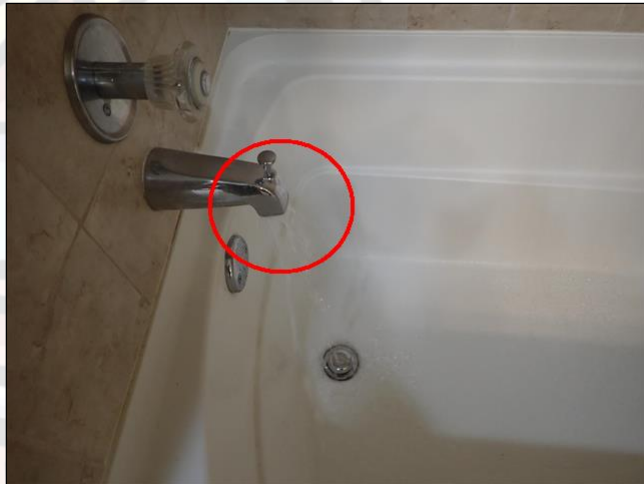
2.1 Picture

(4) The tub diverter in the hall bathroom is defective; likely due from hard water deposit build up on the tub spout mechanism. Water sprays from shower and tub spout simultaneously. We recommend necessary corrections by a qualified person.

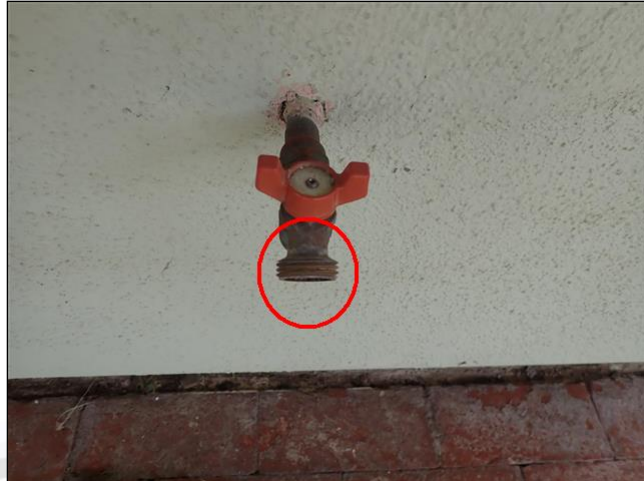
2.2 Picture

(2) **Safety Tip:** Anti-siphon or anti-backflow valves are not present at the exterior hose spigots. These are safety devices which prevent contaminated water from flowing into the the house water supply. Current standards require the installation of anti-siphon valves to keep your drinking water clean. We recommend installation for your health and safety.

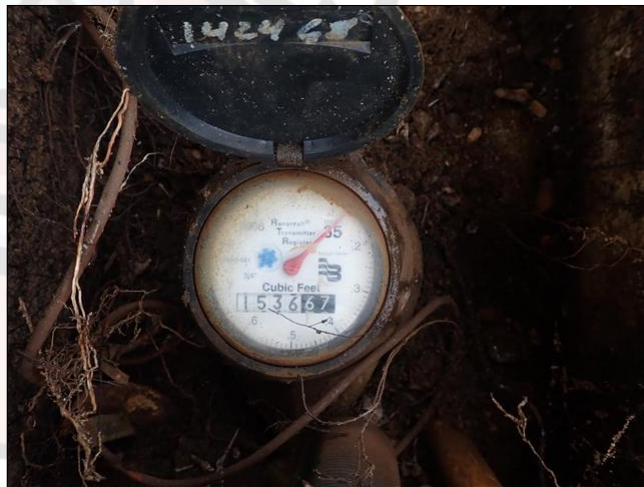
2.3 Picture

(1) **Note:** The water meter was observed for an extended period of time with plumbing fixtures, washing machine, dishwasher, sprinkler system, and any other water-using systems, devices and fixtures turned off. No movement of water meter was observed.

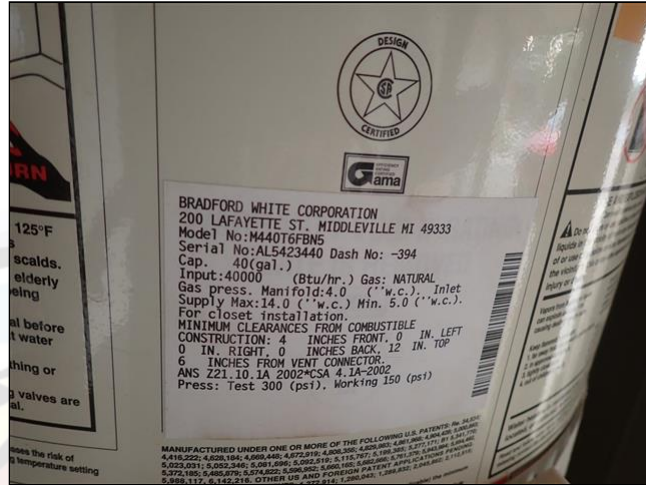
2.5 Picture

(1) The water heater is an older unit (10 years+), and repairs or even failure can be expected. The hard water in Southern California can contribute to early failure. In addition to avoiding leaks, a new water heater can save you money through more efficient operation. Advise replacing the water heater as preventative maintenance. We recommend that keep a good home warranty in place which covers the water heater. For more information visit: <http://www.nachi.org/lifespan-water-heater.htm>

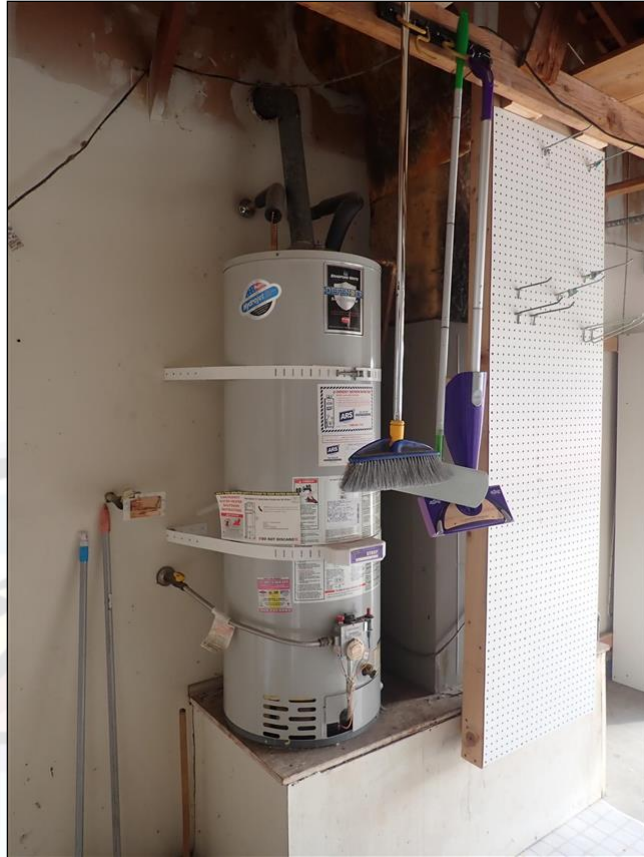
2.5 Picture

(2) The water heater was inspected and was operational at time of inspection. A home inspection does not evaluate the efficiency or recover rate of water heaters.

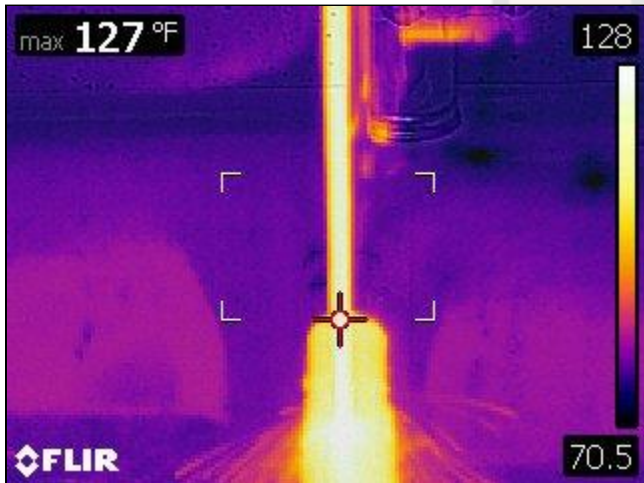
2.5 Picture

(3) Hot water temperature was tested at faucets during inspection and was found to be operating within normal range which indicates the water heater was functioning as intended.

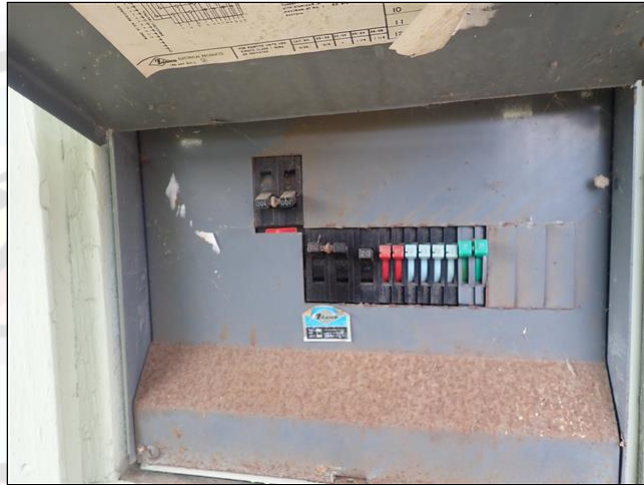
3.0 Picture

MAINTENANCE TIP: The breakers are not labeled. We recommend properly labeling the breakers for safety.

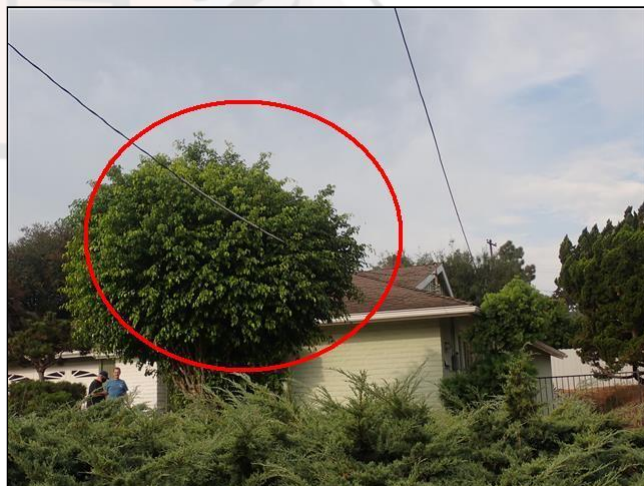
3.1 Picture

The service entrance conductors are in contact with tree branches. This can damage the wires, or cause power outage in high wind. We recommend trimming trees away from service entrance conductors.

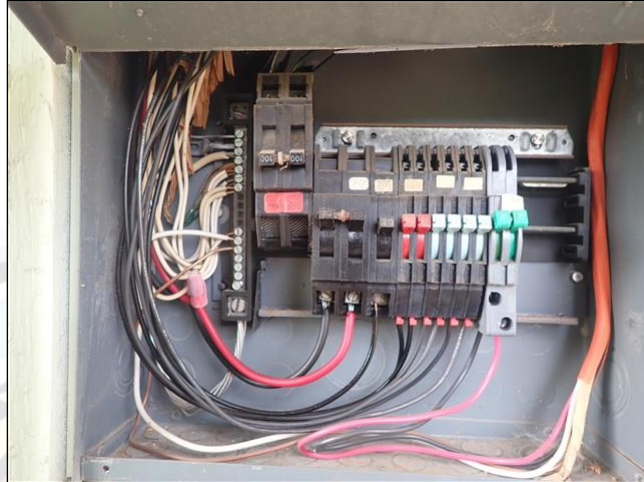
3.3 Picture

The panel was manufactured by Zinsco/ Sylvania. These panels were made with alloy buss bars which are easily dented. Because of this, a poor connection with the circuit breakers sometimes develops. This can cause over-heating which is a fire hazard. We recommend that you consult with a licensed electrician as to the integrity of this electric panel before the close of your contingency period. More information can also be found at <http://www.inspect-ny.com/electric/Zinsco.htm>

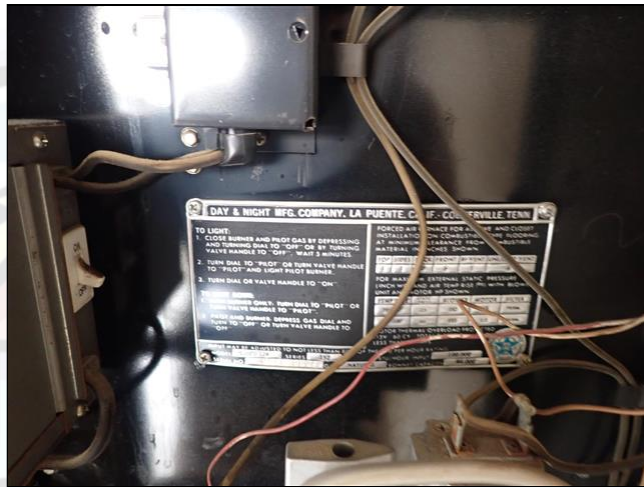
4.0 Picture

(1) The furnace is more than 30 years old. Most heating contractor consider units over 20 years old to be at the end of their life span ([Table of Life Expectancy](#)). Furnaces that are more than 30 years old do not have many of the safety features of newer units, and are also far less efficient that a newer unit. Due to its age, this furnace is excluded from our Inspection Guarantee. We advise consulting with a heating contractor to review the system for an estimate of life remaining, and the cost of replacement prior to the end of your contingency period. We also recommend having SDG&E or a heating contractor perform an annual safety test each season before use. Note: We specifically disclaim cracks in furnace heat exchangers because proper evaluation requires invasive, technically exhaustive measures that exceed the scope of the General Home Inspection.

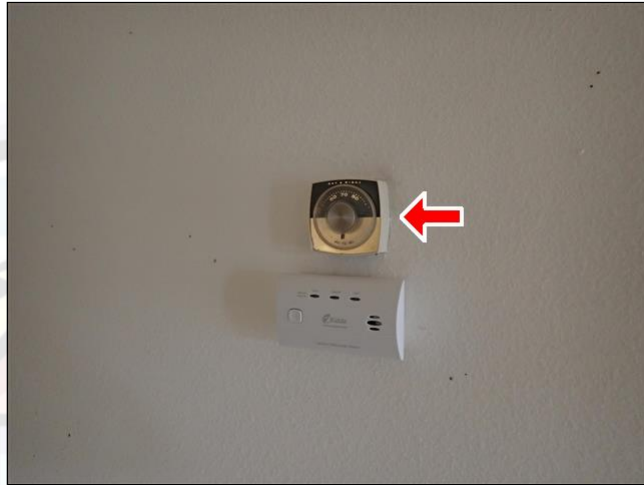
4.3 Picture

(1) The thermostat was operational when used to operate the HVAC system. Programmable thermostats are not adjusted, and no testing is done to check the accuracy or programmed settings of the thermostat.

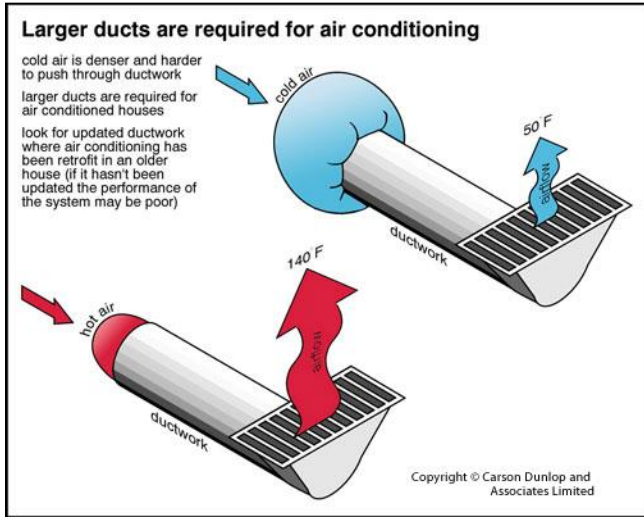
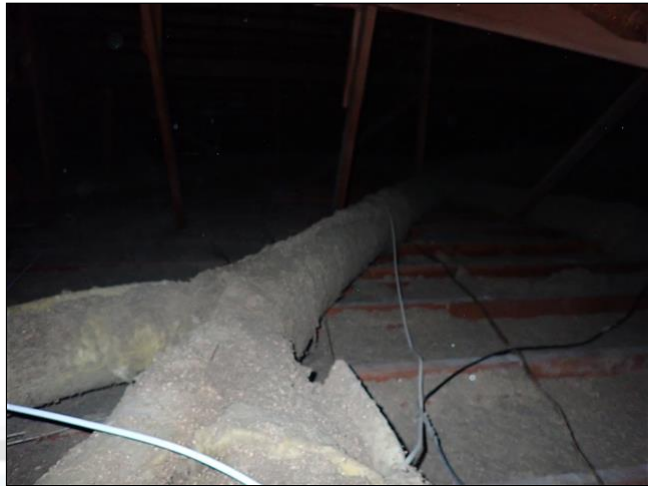
4.4 Picture

(1) This home appears to have the original heat ducting system in place. The original ducts were intended for use with heat (furnace) only and are too small for air conditioning. This home has had an air conditioning system added which requires larger ducts. While the system does function, you may be unsatisfied with the performance of the AC system in the summer months. Upgrading the ducting system may be desired. We recommend review by a licensed HVAC contractor.

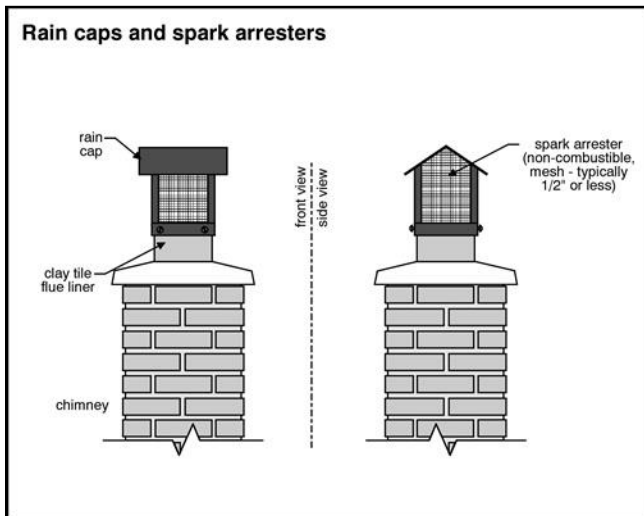
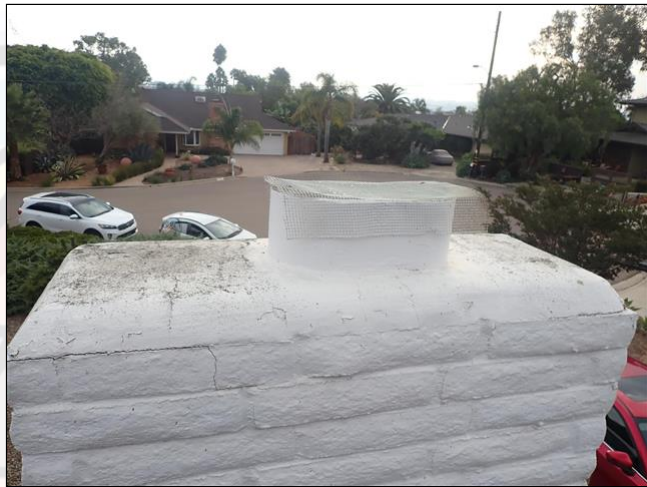
6.0 Picture

(1) No spark arrester/ rain cap was present. Spark arresters prevent cinders from falling onto the roof which is a fire hazard. The rain cap prevents water from entering the chimney flue. We recommend installing a spark arrester/ rain cap by a qualified person.

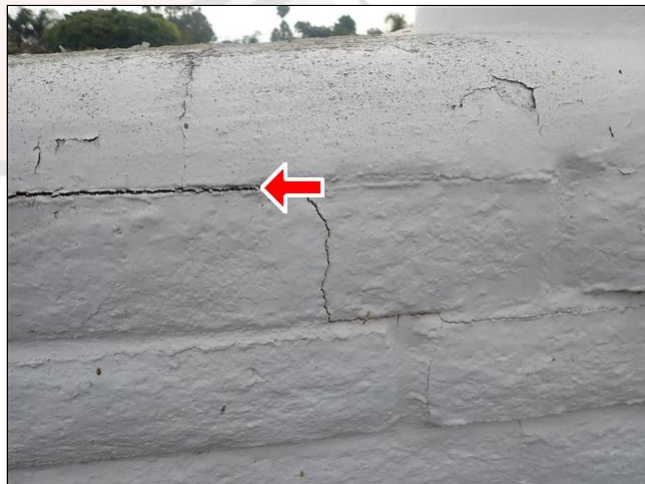
6.0 Picture

(2) The chimney crown (mortar cap) is cracked. We advise repair to avoid moisture intrusion and further deterioration by a licensed chimney contractor.

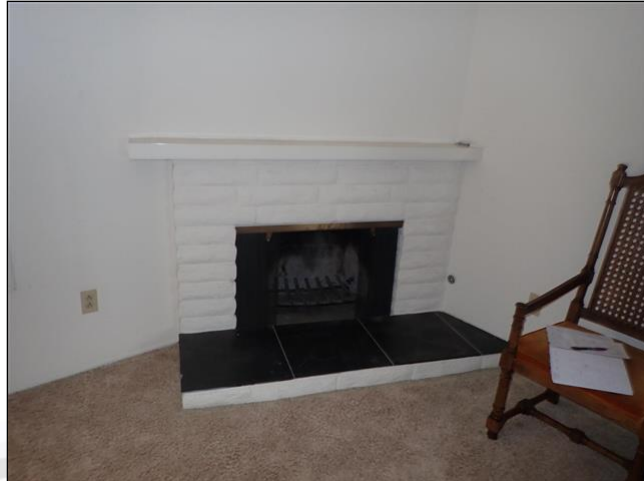
6.0 Picture

(3) **Note:** Our inspection of chimneys is that of a generalist and not a specialist, and is described by specialists as less than a phase-one inspection, as distinct from phase one- and phase-two inspections that are conducted by fireplace specialists. Please note that significant areas of chimney flues cannot be adequately viewed during a home inspection. Phase-one inspections have been documented by the [Chimney Safety Institute of America](#) which reported in 1992 "The inner reaches of a flue are relatively inaccessible, and it should not be expected that the distant oblique view from the top or bottom is adequate to fully document damage even with a strong light." Therefore, because our inspection of chimneys is limited to those areas that can be viewed without dismantling any portion of them, and does not include the use of specialized equipment, we will not guarantee their integrity or drafting ability and recommend a phase-two inspection by a specialist within the contingency period to fully document the condition of the flue in its entirety.

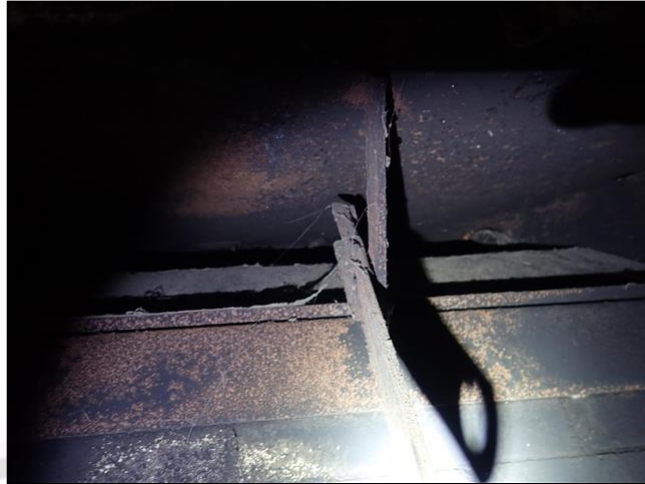
6.1 Picture

SAFETY TIP: A damper clamp is required when there is a gas supply to the fireplace(s). This damper clamp prevents the damper from closing all the way as a safety precaution. If the damper is closed, Carbon Monoxide gas can enter the living space which is undetectable. We recommend installation of a damper clamp.

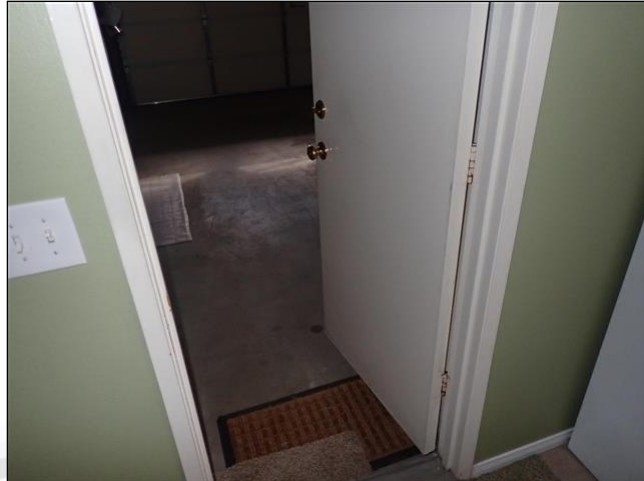
7.1 Picture

The required auto-closing hinge was not installed and requires installation at door to garage. We recommend installing.

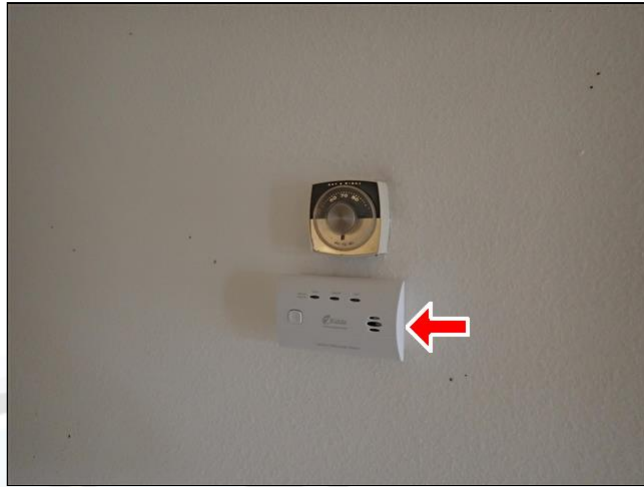
7.5 Picture

Carbon Monoxide detectors are required as of July 1, 2011, in homes with any gas burning appliances (furnace, range, water heater), fireplaces, or wood burning stoves and/or an attached garage. Please see the [new law regarding Carbon Monoxide detectors](#). This house has CO detector(s) installed as required.

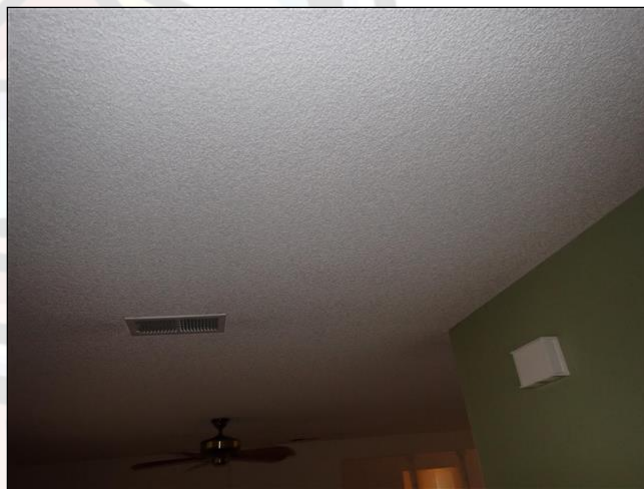
8.0 Picture

(1) Acoustic texture, also known as "popcorn", was present at the ceiling. This material was often used from the late 1950s into the 1980s in residential construction. Some of this material installed before the 80's has been known to contain asbestos. It is beyond the scope of this inspection to test for asbestos. The only way to confirm the presence or absence of asbestos is by having a sample of the material tested in a lab. If client has any concerns regarding asbestos materials, an asbestos-testing lab should be consulted for further review.

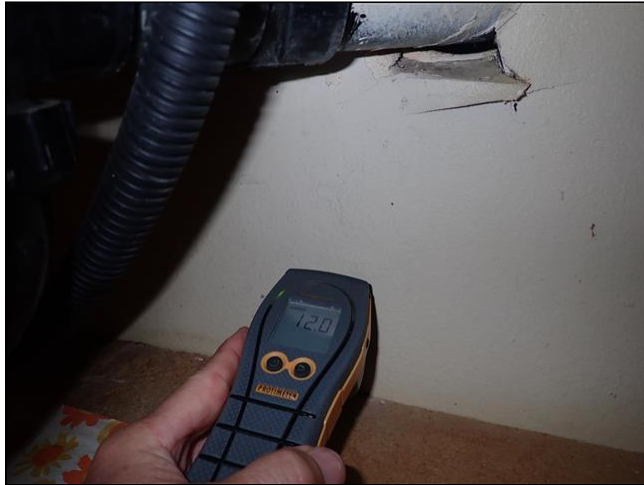
8.0 Picture

windows) No elevated moisture was detected at time of inspection. This is not an exhaustive test and only represents the conditions on the day of inspection.

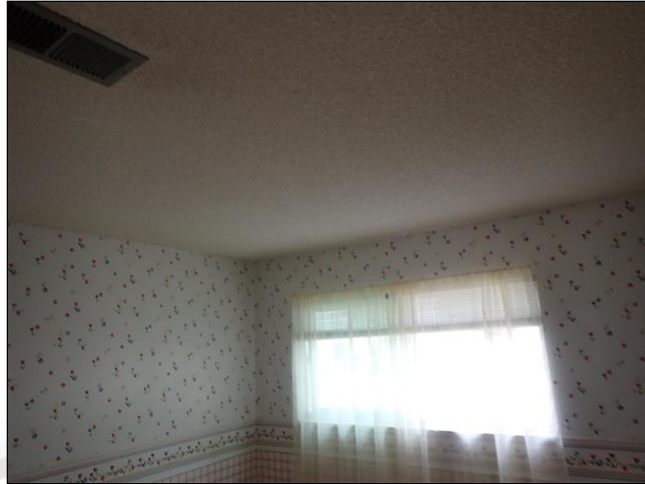
8.0 Picture

(4) Note: Several areas of interior walls were covered in wall paper, therefore much of the sheetrock was not observable for stains, water damage, water intrusion, mold, cracks or other hidden defects that may warrant a further evaluation. Do to the concealed nature of the walls, much of the drywall/sheetrock and surrounding areas were not visible.

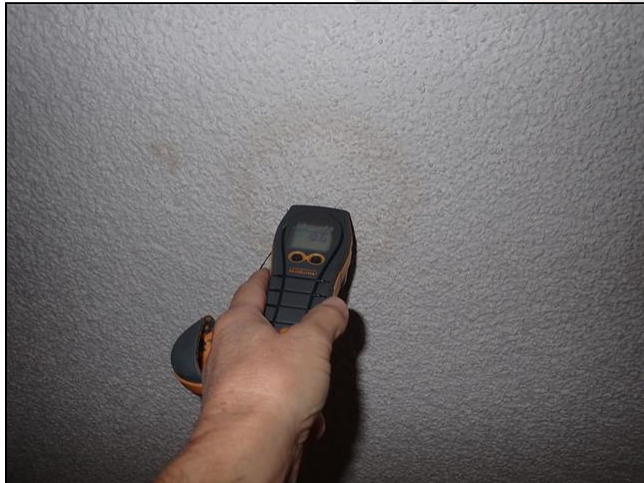
8.1 Picture

Water stains were noted at the ceiling in the 2nd bedroom and 3rd bedroom which can be from a roof leak. These stains were tested for moisture and were found to be dry at the time of the inspection. Due to lack of recent rain, determining the presence of an active roof leak was not possible. We recommend asking the seller if leaks exist, or if repairs have been performed. Otherwise, a licensed roof contractor should be consulted to perform a roof service and inspection prior to the end of the contingency period.

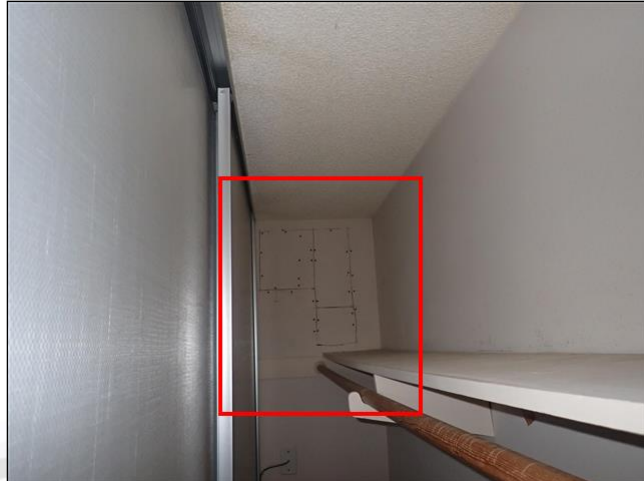
8.2 Picture

Drywall patching noted at the master bedroom closet. We advise patch and paint by qualified person.

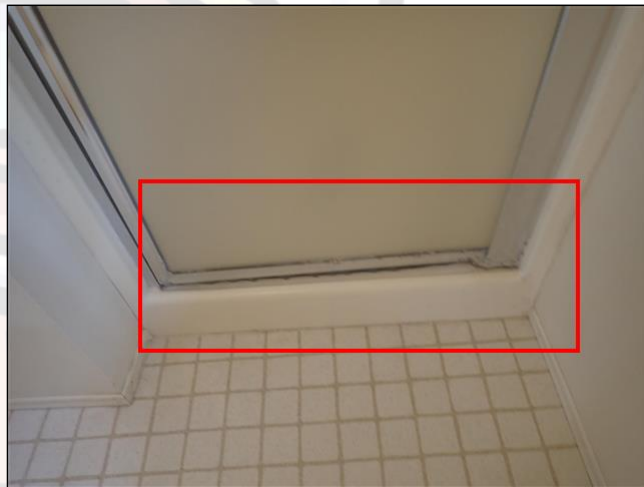
8.4 Picture

Corrosion is noted at the Master Bathroom shower door(s). We advise cleaning or replacing doors as necessary.

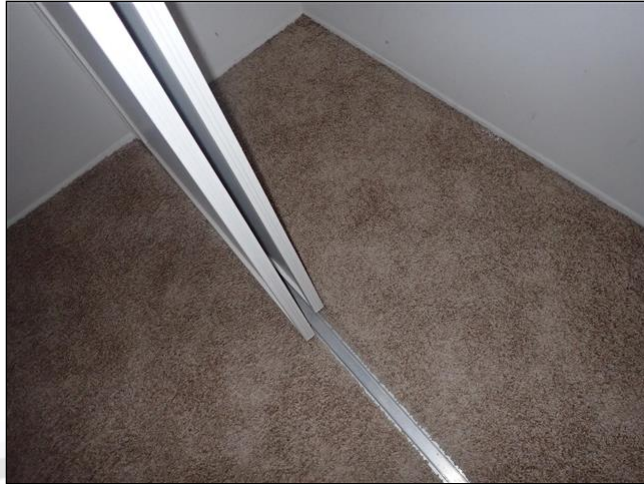
8.6 Picture

(1) Closet door rollers are damaged at 2nd bedroom. We advise repair or replacement.

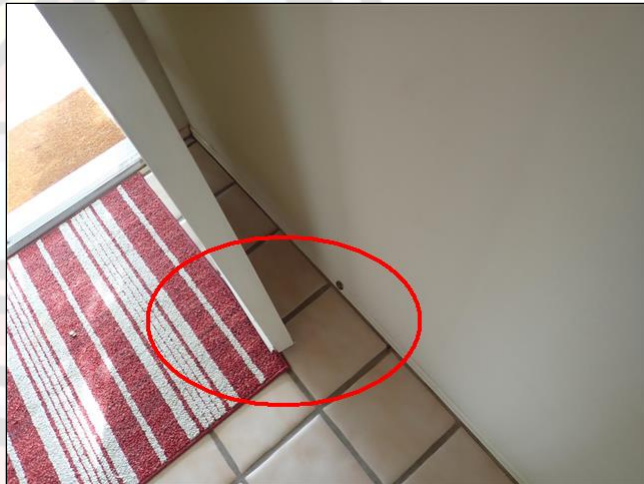
8.6 Picture

(2) Door stoppers are recommended where door handles contact walls. Damage can occur at sheetrock if door handle impacts the wall. Stopper(s) are needed at several locations. We advise adding door stops.

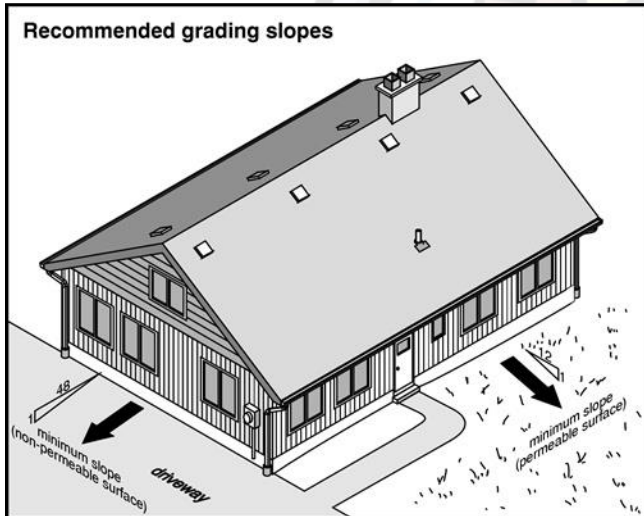
9.0 Picture

(1) Negative slope noted at right side (facing front). This area does not appear to drain water away from the home and needs landscaping and drainage corrections. It is important to prevent or minimize standing water near the house to avoid damage to the foundation. This can be accomplished by properly sloping the ground away from the house and/or adding yard drains to carry water away from the low lying areas. Rain gutters can also be an effective method of diverting water away from the low-lying area. Rain gutters should direct water away from this area. We recommend further evaluation by a qualified landscape contractor.

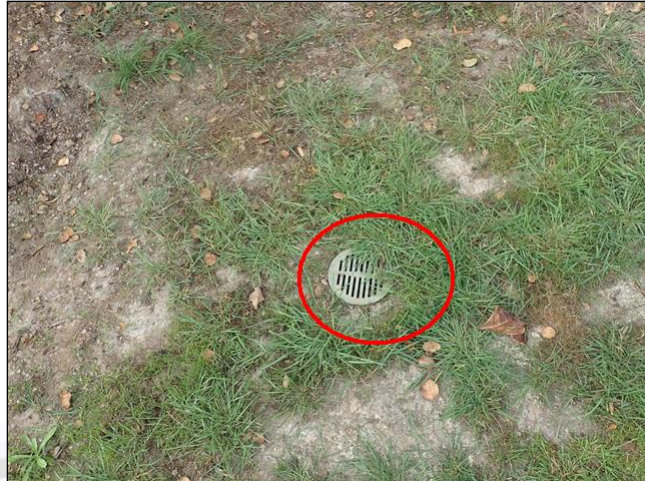
9.0 Picture

(2) **Note:** Ground drain lines were visible in the yard. These drains are not tested for functional flow or adequacy. It is important to maintain these drains and prevent debris from entering. We advise periodic clean out by a qualified person.

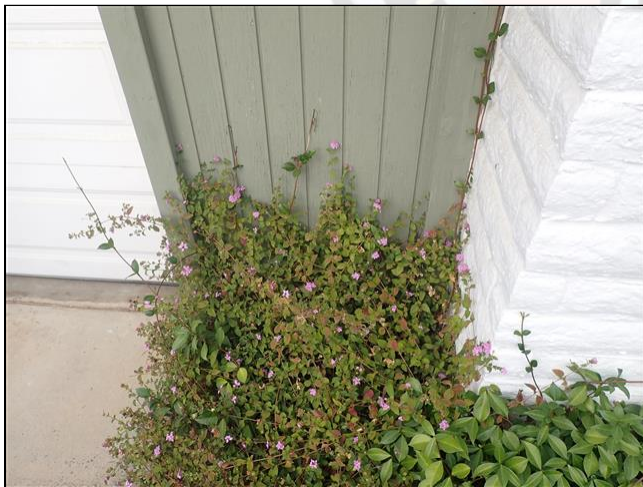
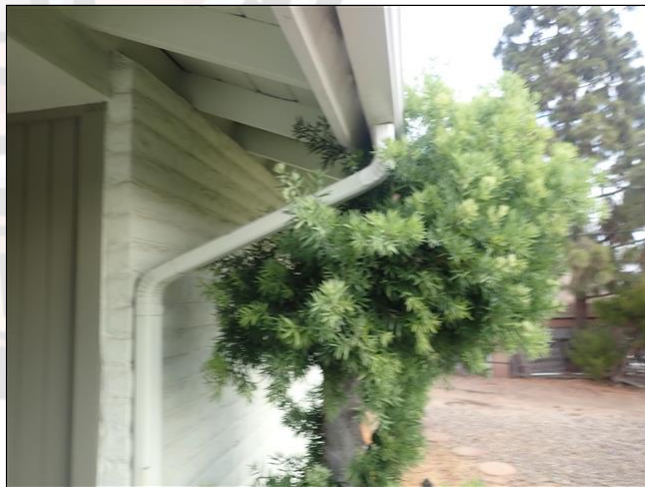
9.1 Picture

Vegetation is in contact with the siding at the Front of home. Vegetation can create moisture problems by preventing siding from drying out. Vegetation also allows rodents to easily access the roof where they can enter through small voids. We advise removing vegetation from the siding. We also recommend referring to the pest control report for their recommendations.

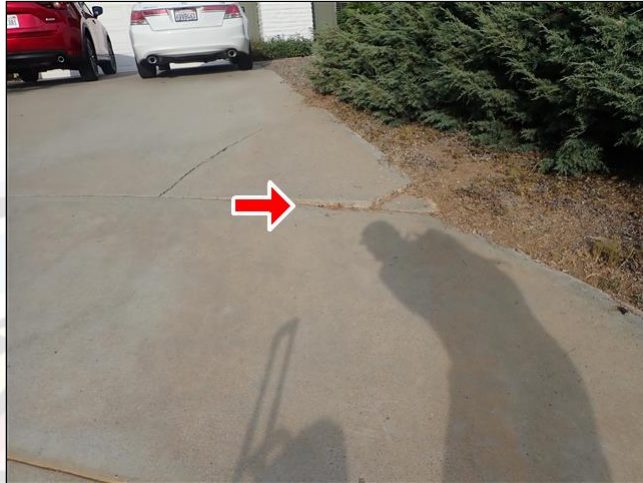
9.8 Picture

(1) Tripping hazard exists at the pathway at the Driveway. We recommend repair to avoid injuries.

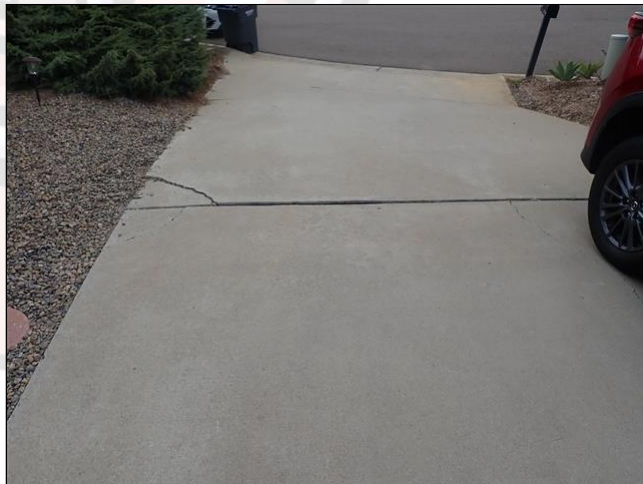
9.8 Picture

(2) Stress and/ or settling cracks are noted in the driveway. This may indicate that soil movement is occurring, there may be root encroachment, or the concrete was installed without re-enforcement. This driveway may deteriorate further. We recommend obtaining a quote for repair/replacement by a licensed concrete contractor prior to the end of your contingency period.

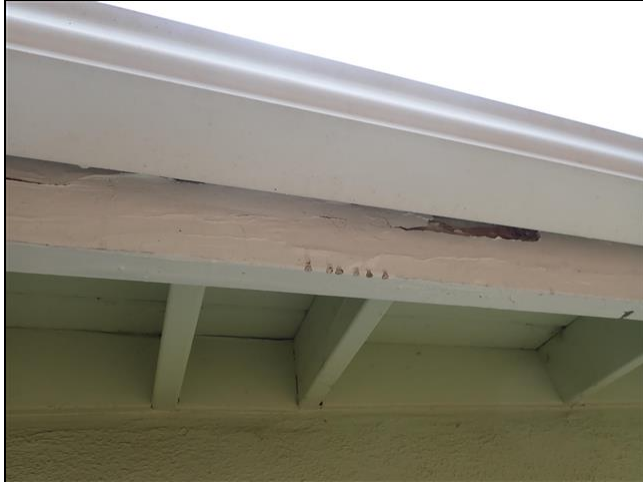
9.9 Picture

Some damaged wood was observed at the eaves and fascia boards. Determining if this damage was caused by termites is beyond the scope of a home inspection. Home inspectors do not have the authority to comment on termites or dry rot, which is the responsibility of a state licensed pest inspector. We recommend referring to the pest inspection report for a full evaluation and necessary repairs made by a qualified licensed contractor.

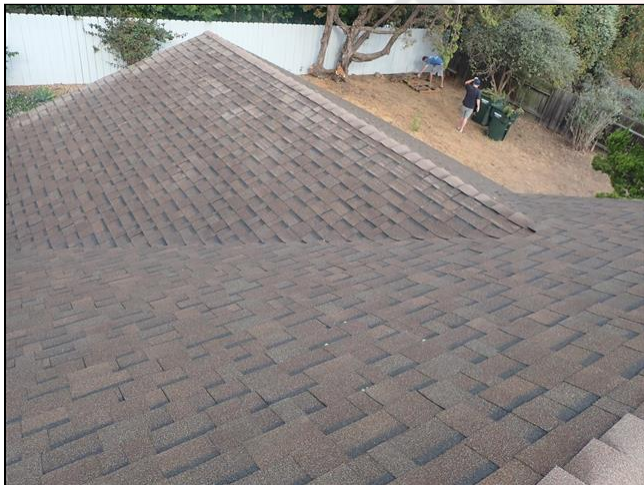
10.0 Picture

(1) The roof has composition asphalt shingles installed over a layer of wood shakes. This condition will result in the following: Reduced asphalt shingle service-life compared to similar shingles installed over a proper substrate. Any warranty which may have been in effect will be void. Proper installation of new shingles will require removal of all roof-covering materials and installation of solid sheathing over the existing spaced sheathing. This will be relatively expensive. We recommend you consult with a licensed roofing contractor to discuss options and costs for any eventual roof-covering material replacement.

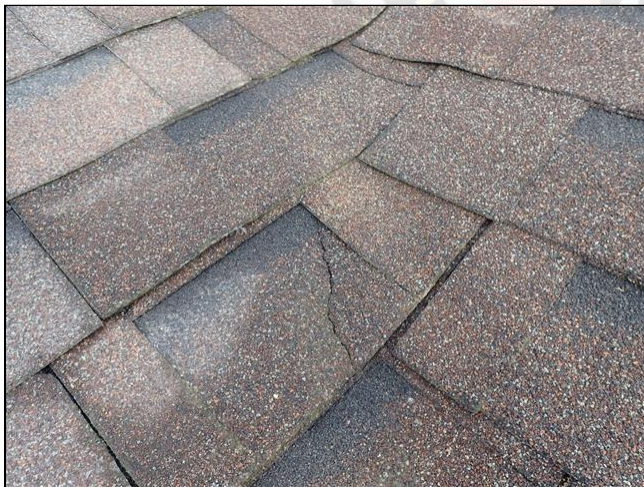
10.0 Picture

(3) Some damaged roof shingles observed. We recommend necessary repairs by a licensed roof contractor.

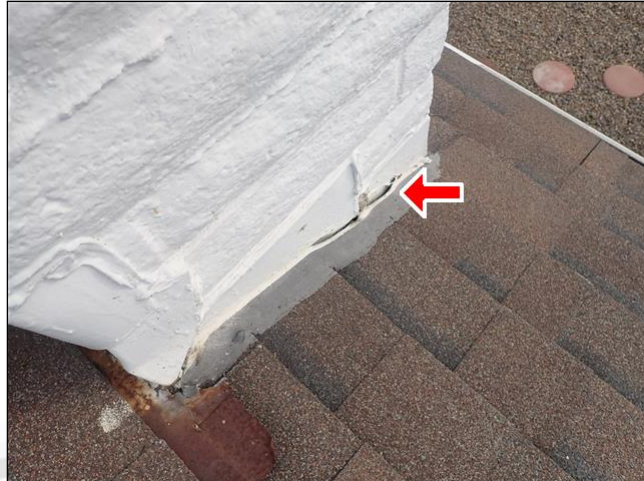
10.1 Picture

(1) The chimney flashing is loose and needs repair. We advise further evaluation and necessary repairs by a licensed roof contractor.

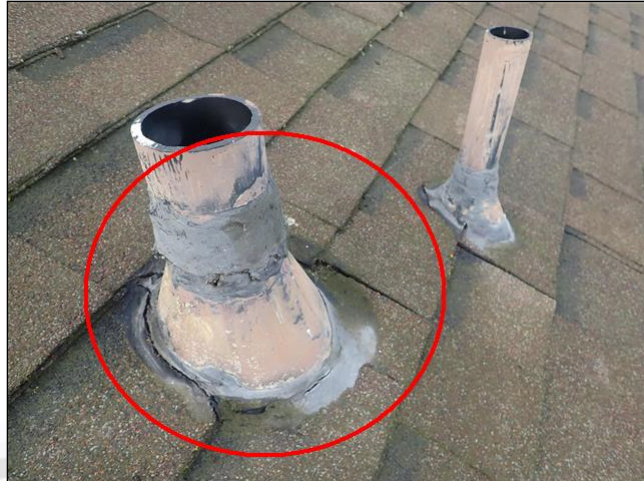
10.1 Picture

(3) Sealant around flashings is cracked at plumbing vent pipe(s). We advise further evaluation and/or corrections by a licensed roofer.

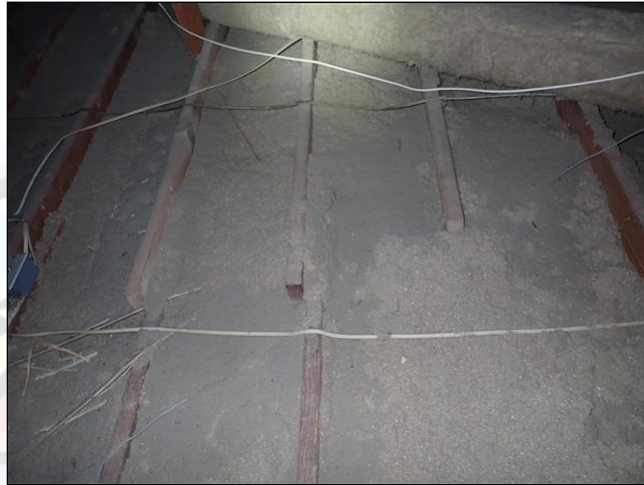
12.0 Picture

(1) The insulation in the attic is compressed. We recommend increasing the amount of insulation to improve the thermal efficiency of the house.

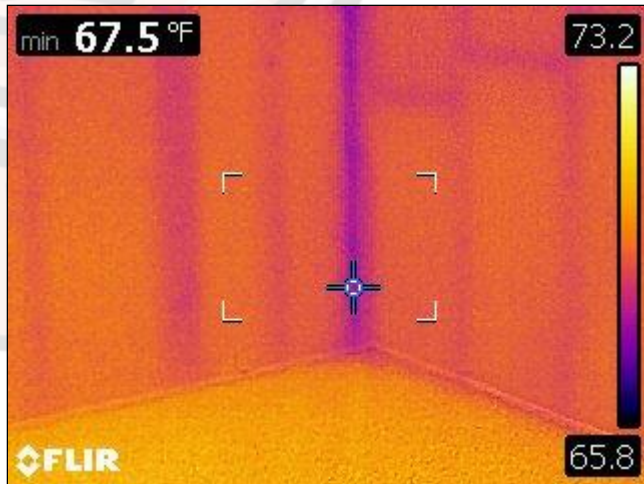
12.0 Picture

(2) Exterior walls were observed with thermal camera and it appears they are not insulated. This condition will result in significant heat gain and loss through the exterior walls, increasing home heating and cooling costs and lowering comfort levels. We recommend that you consult with a qualified contractor to discuss options and costs for installing thermal insulation in the exterior walls.
