HOME INSPECTION REPORT

Date: 10/6/2020	Time: 08:30:00 AM	Report ID: 201006-31635
Property: 938 Doris Dr Encinitas CA 92024	Client: Tom White	Real Estate Professional: The Caspersen Brothers
Inspector: Brian Pennington	Support Phone: (760) 203-9682	Website: www.sdinspect.com

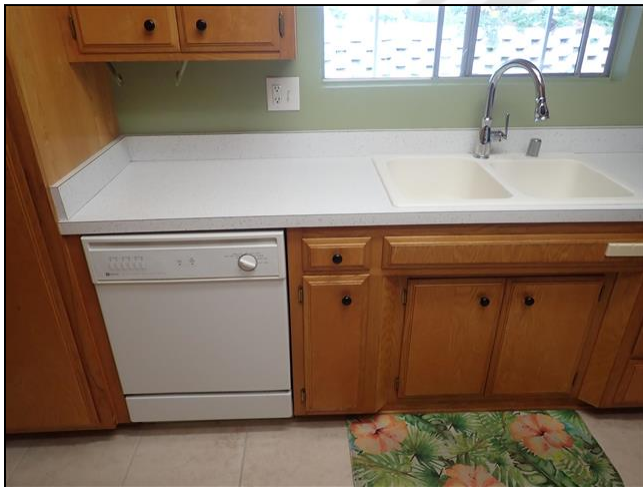
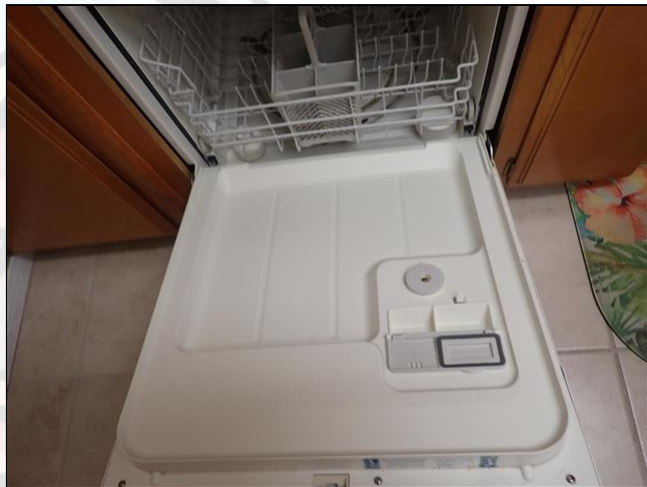
1.0 Picture

(1) The dishwasher was tested and functioned properly at the time of the inspection. This is not an exhaustive test and does not verify the cleaning efficiency of the dishwasher.

(2) **Note:** The dishwasher appears to be past its expected service life. The average life of a dishwasher is 10 years. Some units may last for more or less than 10 years depending on quality and usage. To see a complete list of life expectancies for just about every component in a house, please visit our list of [Life Expectancy](#).

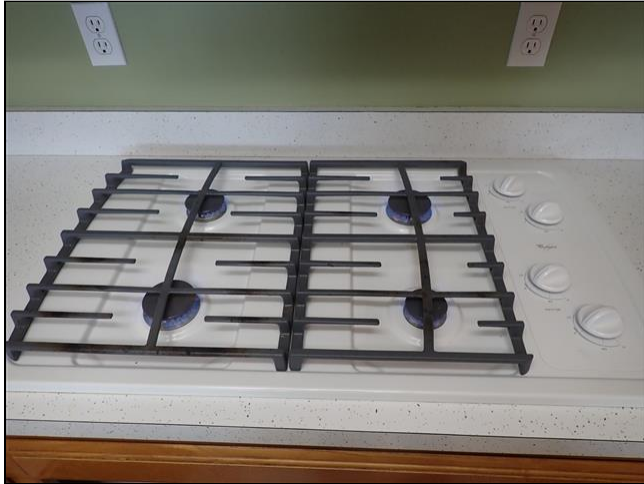
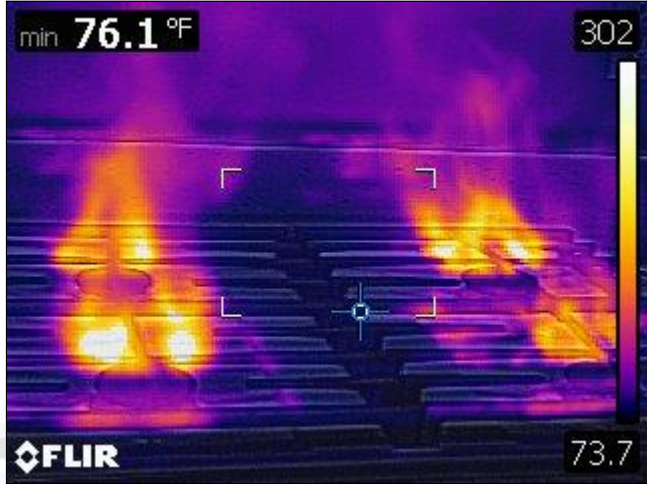
1.1 Picture

(2) Note: The range appears to be older than its expected service life. According to InterNACHI the average life of a gas range is 15-17 years and an electric range is 13-15 years. Some units may last for more or less time depending on quality and usage. To see a complete list of life expectancies for just about every component in a house, please visit our list of [Life Expectancy](#).

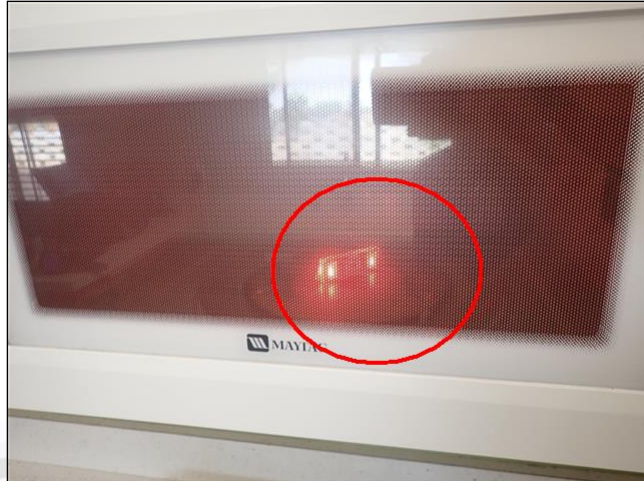
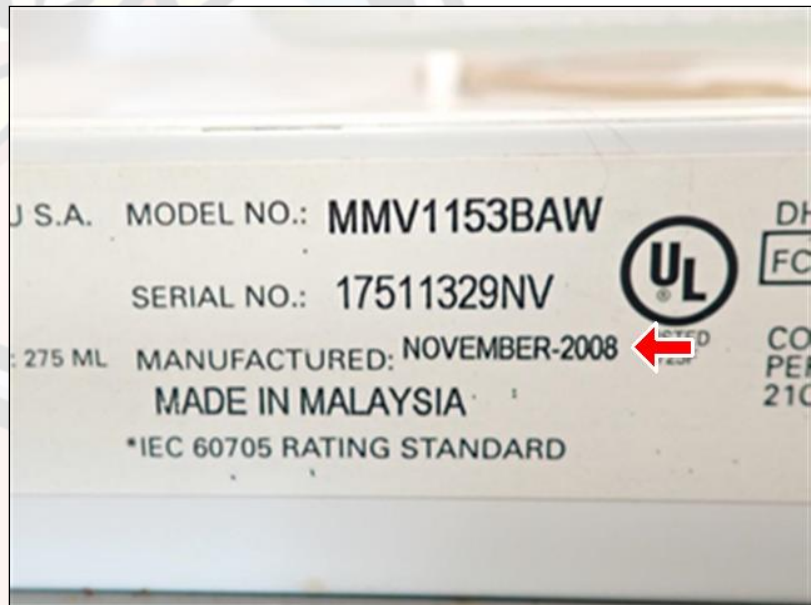
1.4 Picture

(1) The microwave was installed close to the cooktop surface. (less than 18" clearance between cooktop and bottom of microwave) This can cause damage to the plastic covering and the electronic control panel due to excessive heat. Also, this can be a hazard if the burner controls are located behind the cooking surface. We recommend checking the microwave manufacturers clearance requirements and relocating if a greater clearance is recommended.

(3) Note: The average life of a microwave is 11 years. Some units may last for more or less than 11 years depending on quality and usage. To see a complete list of life expectancies for just about every component in a house, please visit our list of [Life Expectancy](#).

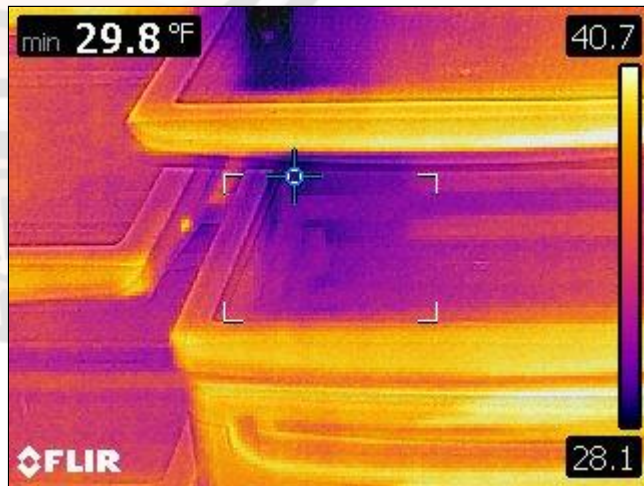
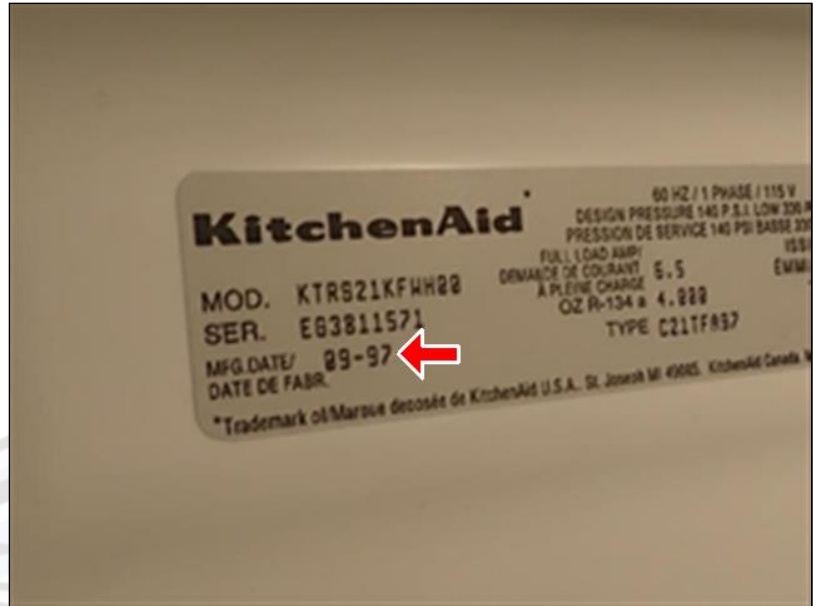
1.6 Picture

(1) The interior temperatures of refrigerator and freezer were observed using a thermal camera and the refrigerator appeared to be functional. This is not an exhaustive test and does not verify the efficiency of the refrigerator. Appliances are not moved to inspect the walls/floors/other components behind them. We recommend that you keep a good home warranty in place which covers the appliances.

(2) Note: The refrigerator appears to be older than its expected service life. The average life of expectancy is 9-13 years. Some units may last for more or less time depending on quality and usage. To see a complete list of life expectancies for just about every component in a house, please visit our list of [Life Expectancy](#).

(3) Note: There is no water supply present for a refrigerator with an ice maker/water dispenser.

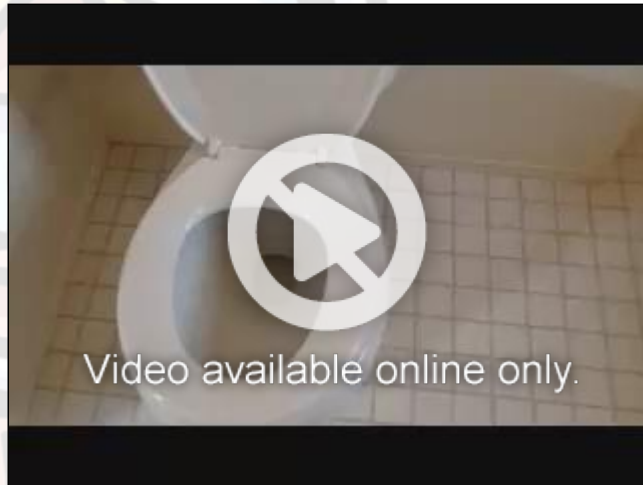
2.0 Picture

Note: We attempt to evaluate drain pipes by flushing every drain that has an active fixture while observing its draw and watching for blockages or slow draining. All bathroom and kitchen fixtures were tested for an extended period of time during the inspection. Home inspectors only run clean water through the drains. This is not a conclusive test and flushing toilet paper, human waste, food debris or soap suds may cause drains to clog. Only a video-scan of the drains and main line would confirm its actual condition. We advise having a sewer camera inspection performed to verify the condition.

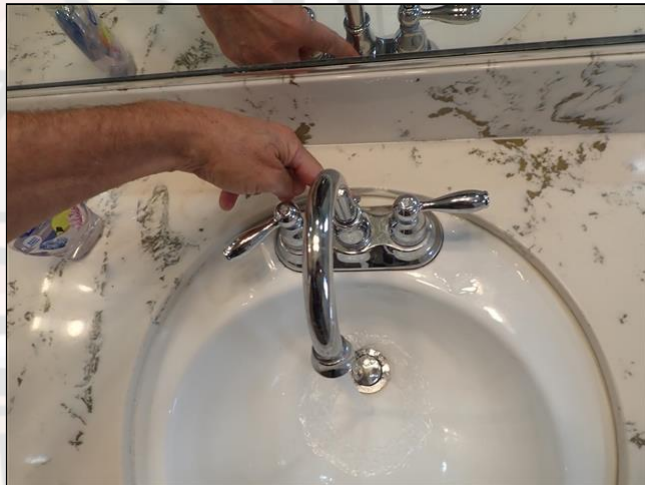
2.1 Picture

(1) One piece valve/flexible supply lines are installed at master bathroom sink. These supply pipes are known to corrode from the inside and fail. Corrosion/ calcification was observed at these valves which indicates that corrosion is taking place. We recommend replacing all of these older angle stop valves with new valves and braided steel supply lines to avoid leaks.

(2) The Master Bathroom and hall bathroom sink stopper is inoperable. We recommend necessary corrections.

(3) The sink in the Master Bathroom is cracked. We recommend replacement to avoid leaks.

(4) The tub diverter in the hall bathroom is defective; likely due from hard water deposit build up on the tub spout mechanism. Water sprays from shower and tub spout simultaneously. We recommend necessary corrections by a qualified person.

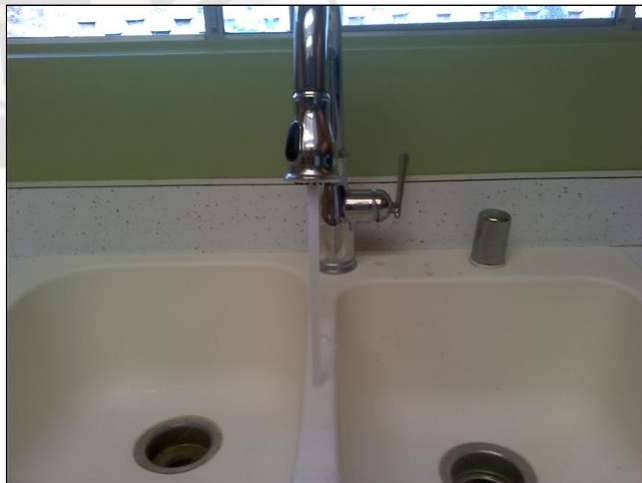
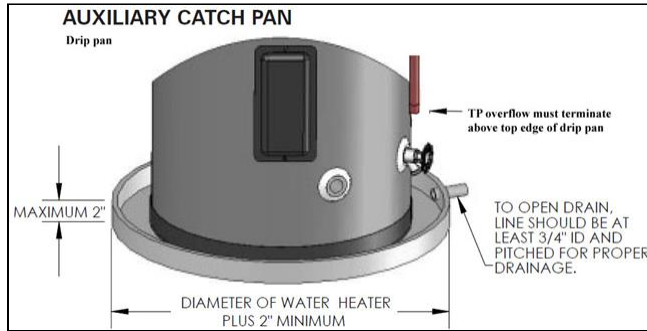
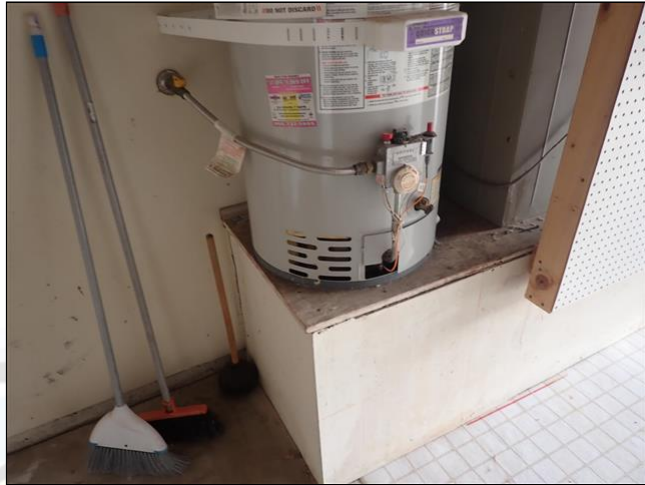
2.5 Picture

(3) Hot water temperature was tested at faucets during inspection and was found to be operating within normal range which indicates the water heater was functioning as intended.

(4) We recommend installing a leak pan under the water heater by a licensed plumber to avoid future damage to the home if the water heater leaks.

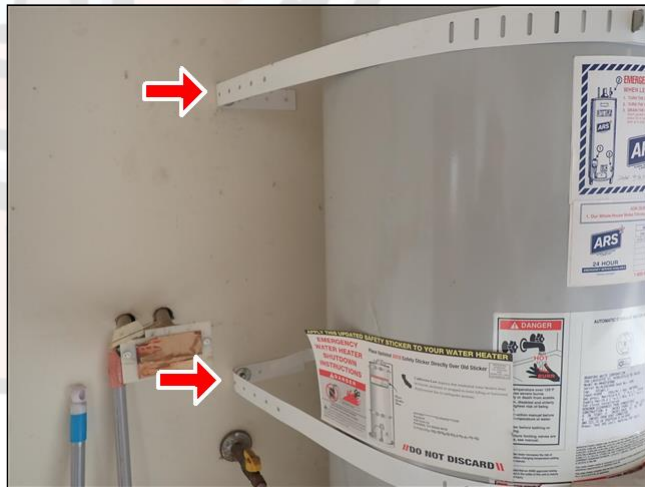
2.7 Picture

Water heater was adequately strapped and blocked against movement.

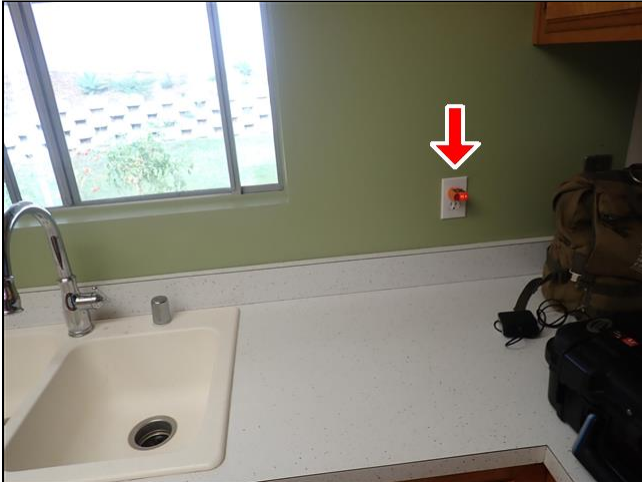
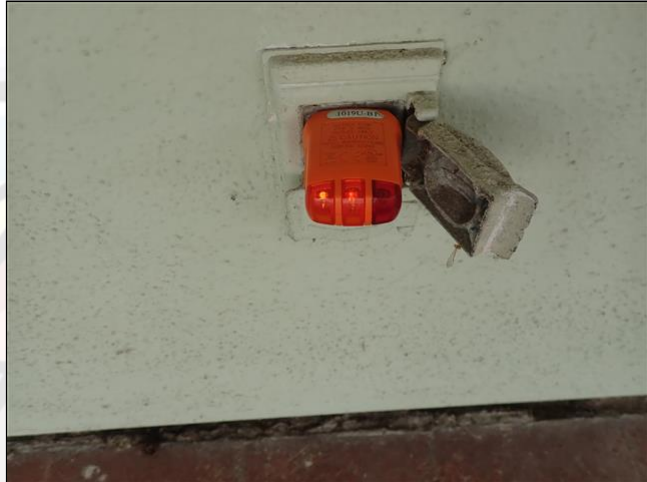
3.9 Picture

(2) **Suggested Safety Upgrade:** This house was built prior to the requirement for the installation of GFCI receptacles in certain locations in the house. The locations where GFCI receptacles are required has increased, but it is not required to retrofit older homes unless a remodel takes place. For safety, it is advisable to upgrade all receptacles within 6 feet of a plumbing fixture, in garage, kitchen, and at exterior, to GFCI protected outlets by a licensed electrician. A complete list of GFCI installation requirements and the dates that they were first required can be viewed at www.sdinspect.com

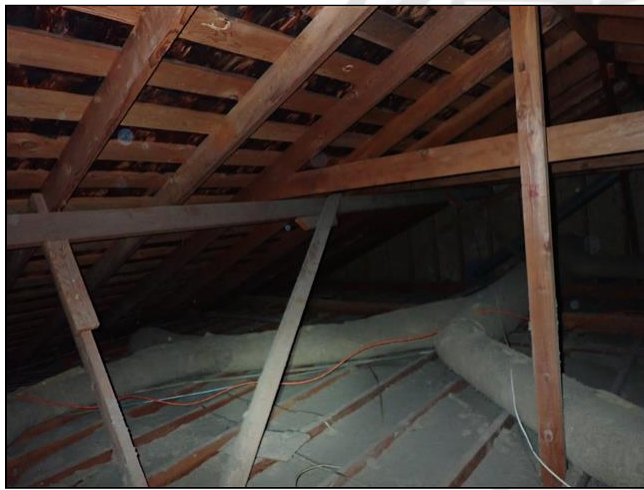
4.4 Picture

(2) There is possible asbestos-type material at ducting. The only way to confirm the presence or absence of asbestos is by having a sample of the material tested in a lab. If client has any concerns regarding asbestos materials, an asbestos-testing lab should be consulted for further review prior to the end of your contingency period.

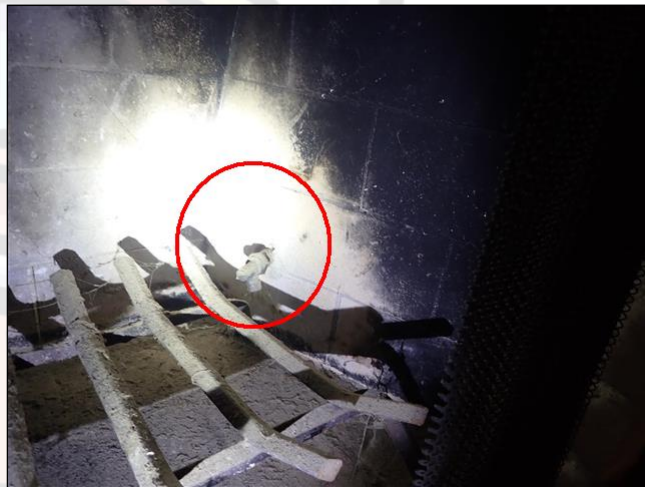
6.3 Picture

Gas valve or gas supply at the fireplace could be not tested. Gas stub inside fireplace was capped. We could not confirm the presence or function of gas at fireplace.

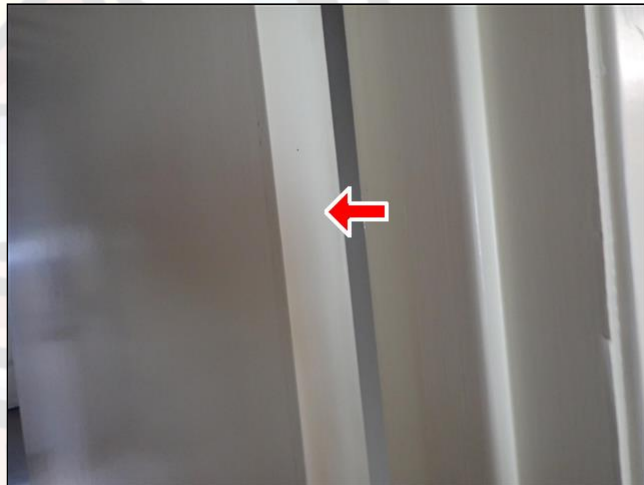
7.0 Picture

The door between the house and the garage appears to be a fire rated door.

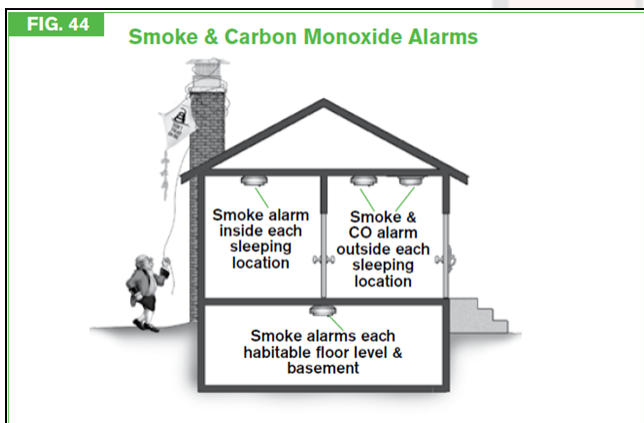
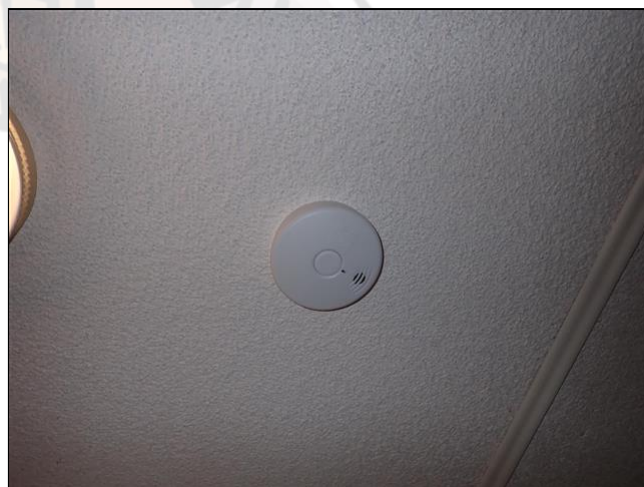
One smoke detector was present in the common hallway. As of January 1, 2014, California State Law SB 745 requires additional smoke detectors to be installed in all bedrooms and on each level in the common hallways in multi-story homes when modifications have been performed including alterations, repairs, or additions exceeding \$1,000 in value. Additional smoke detectors area also required in all dwellings intended to be used as rentals regardless of modifications.

Additional smoke detectors are needed to comply with current fire and safety standards and regulations. To see the requirements, please visit our website at [Smoke Detector Requirements](#).

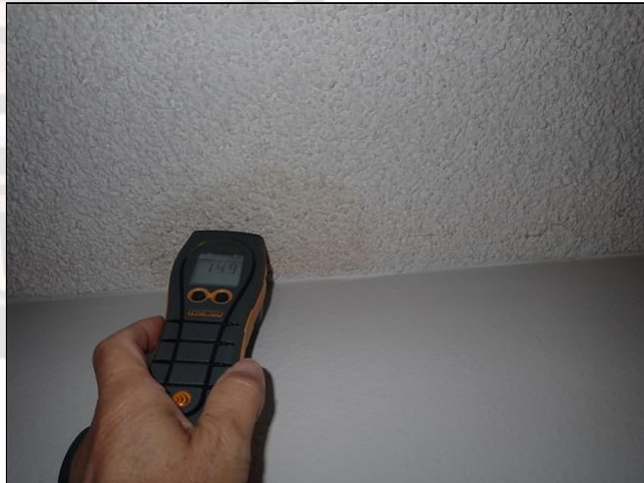
8.1 Picture

Water stains were noted at the ceiling in the 2nd bedroom and 3rd bedroom which can be from a roof leak. These stains were tested for moisture and were found to be dry at the time of the inspection. Due to lack of recent rain, determining the presence of an active roof leak was not possible. We recommend asking the seller if leaks exist, or if repairs have been performed. Otherwise, a licensed roof contractor should be consulted to perform a roof service and inspection prior to the end of the contingency period.

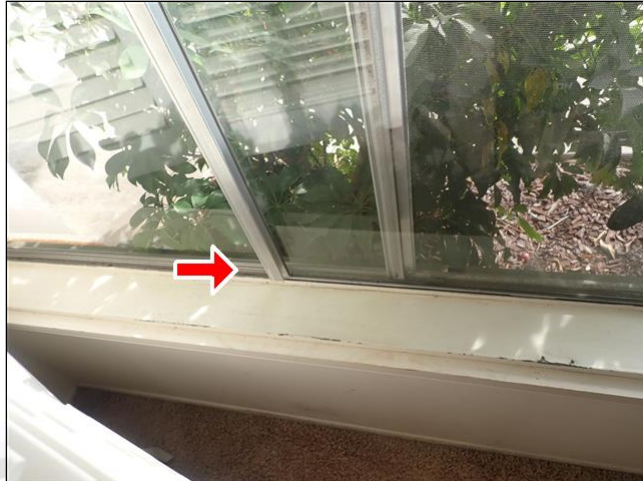
8.7 Picture

The window glides for sliding windows are worn. This causes metal-on-metal friction. The added force required to open and close the windows can lead to breakage. We recommend replacing all of the window glides.

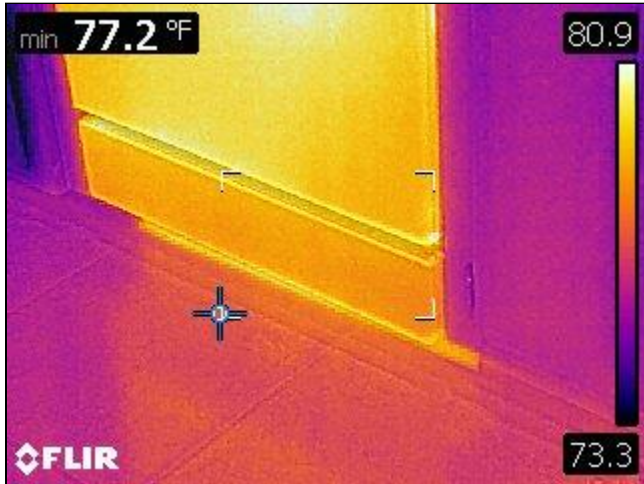
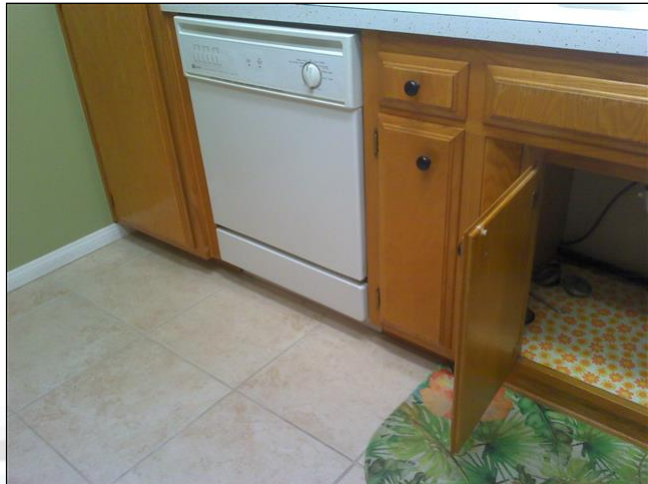
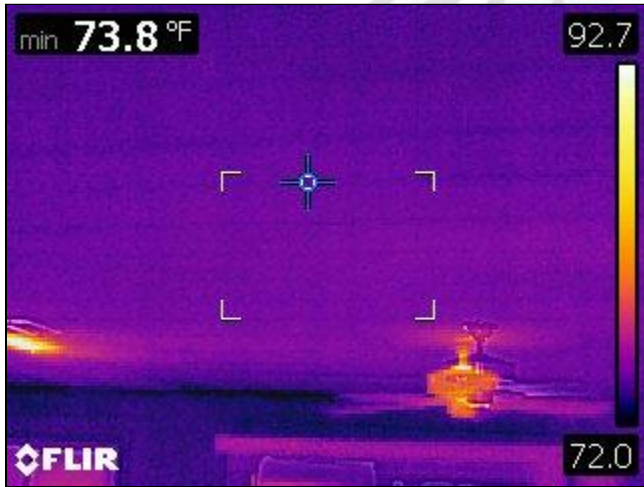
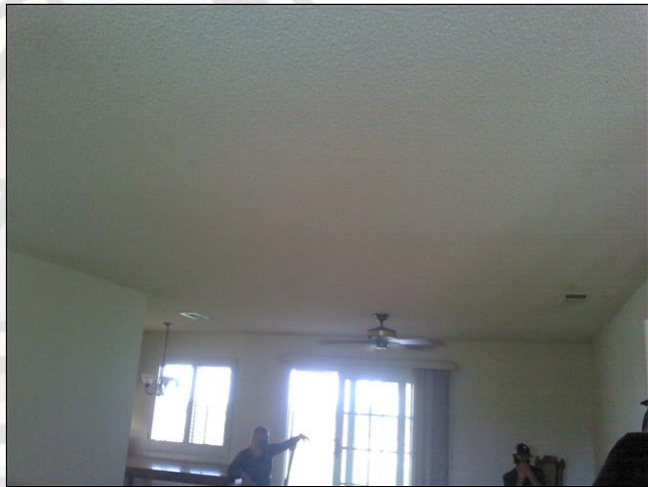
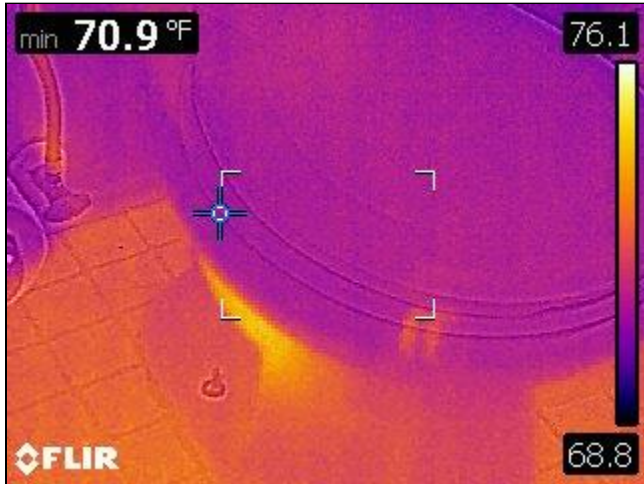
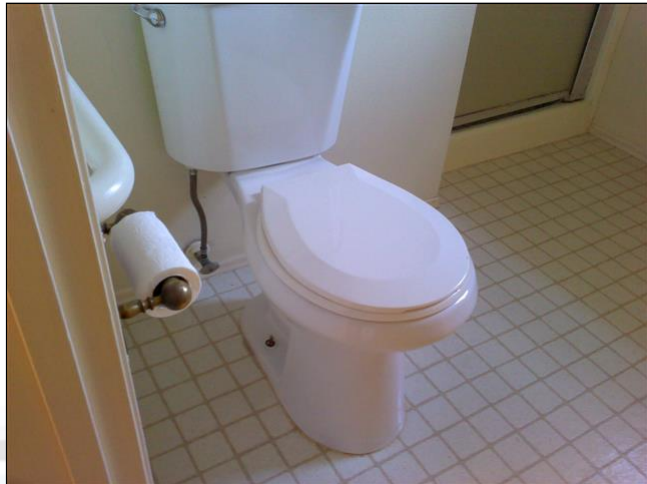
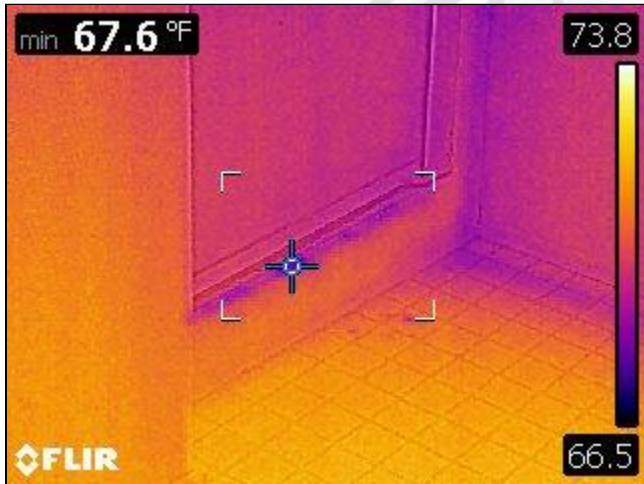
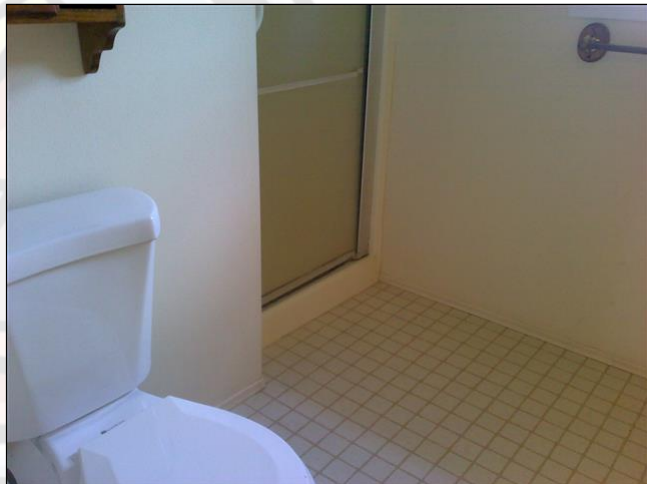
(2) An infrared scan was performed in the house. No anomalies were found.

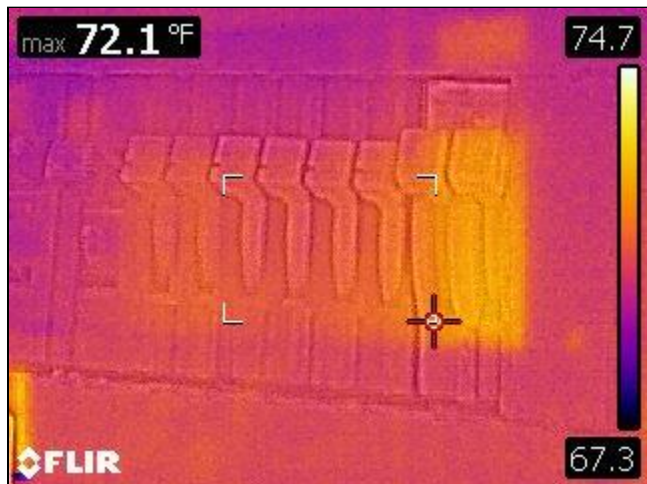
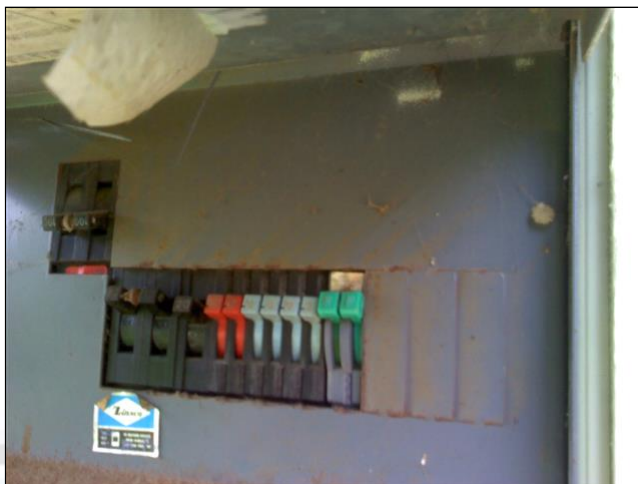
(3) A thermal scan was performed at electrical panel(s). The panel, circuit breakers and wiring were found to be operating within normal temperature range which indicates the system was functioning as intended with the conditions present at time of inspection.

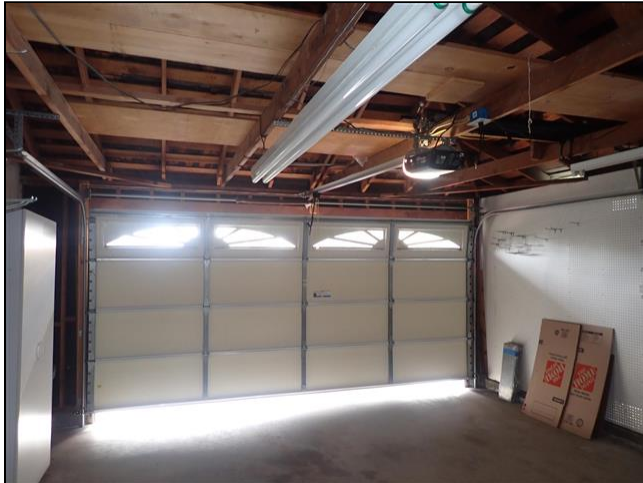
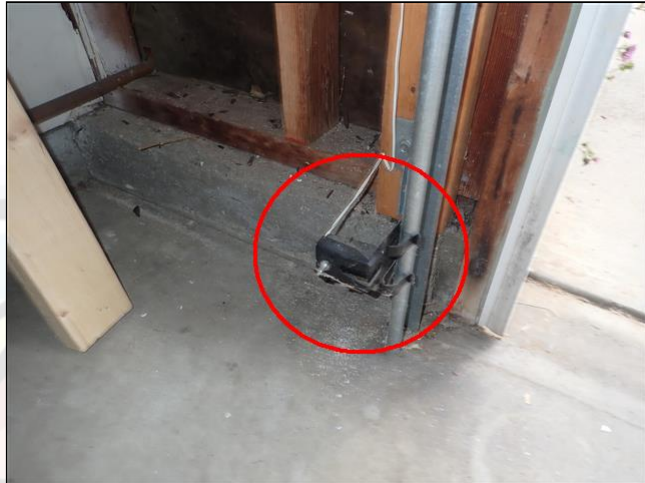
Sensors are in place and will reverse the garage door.

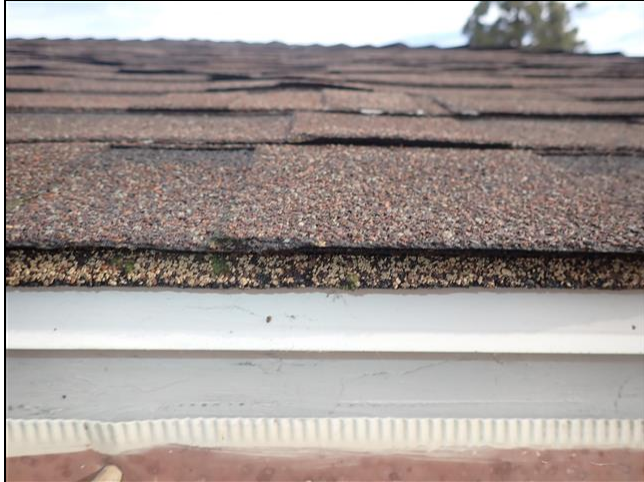
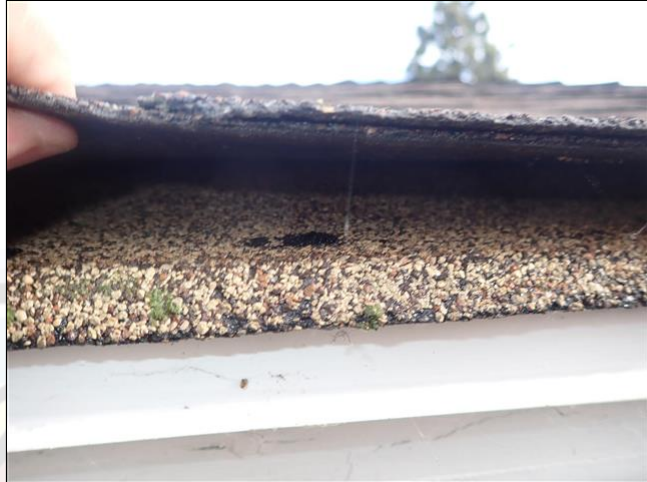
(2) The house roof has several layers on it. The general rule is no more than 3 layers should be installed due to excessive weight. Also, installing new roofing material over an existing roof will shorten the life of the new roof. To be sure there are not too many layers, a core test is required by a licensed roofer. At a minimum, the house roof will need to be re-sheathed when the next roof is installed.

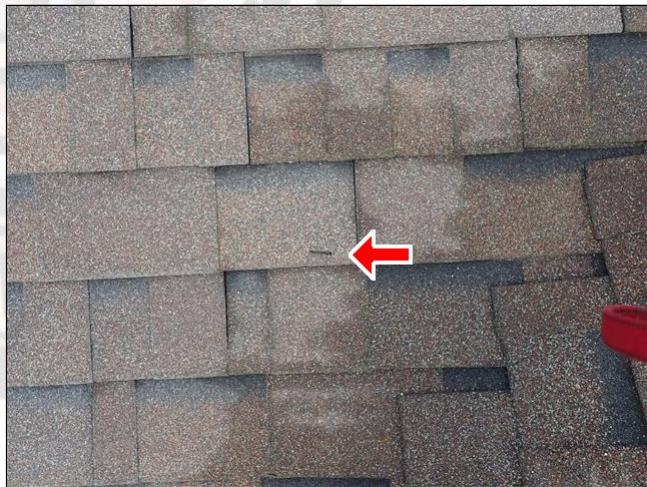
10.0 Picture

(3) Some damaged roof shingles observed. We recommend necessary repairs by a licensed roof contractor.

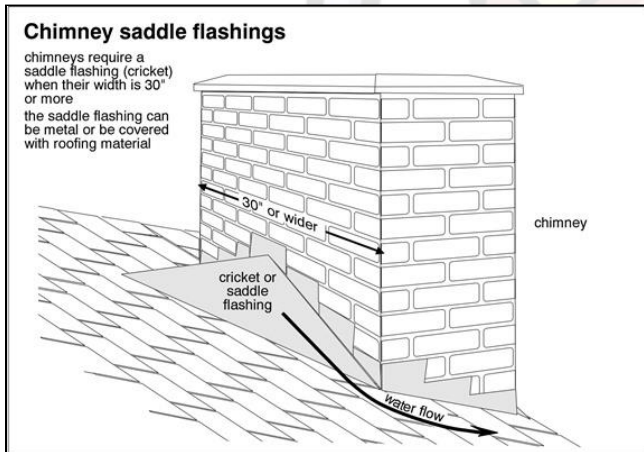
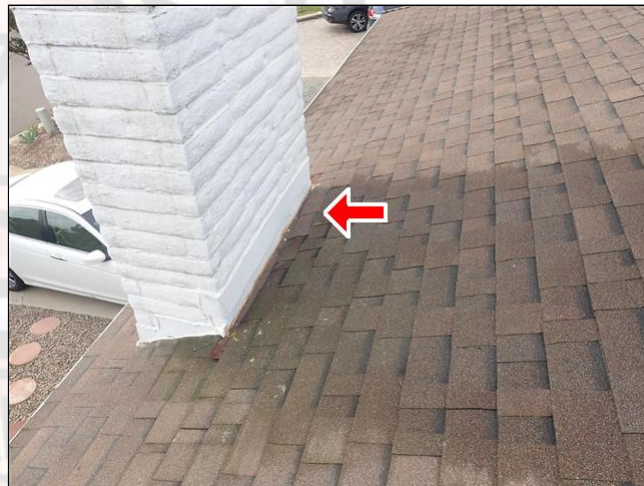
(2) No saddle or cricket flashing was installed at chimney. This is required when chimneys are 30 inches wide or more. We recommend correction by a licensed roof contractor.

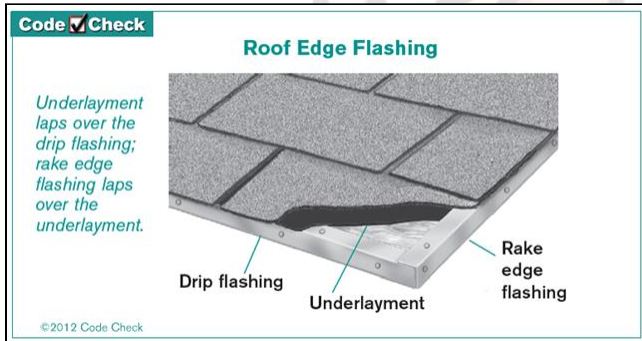
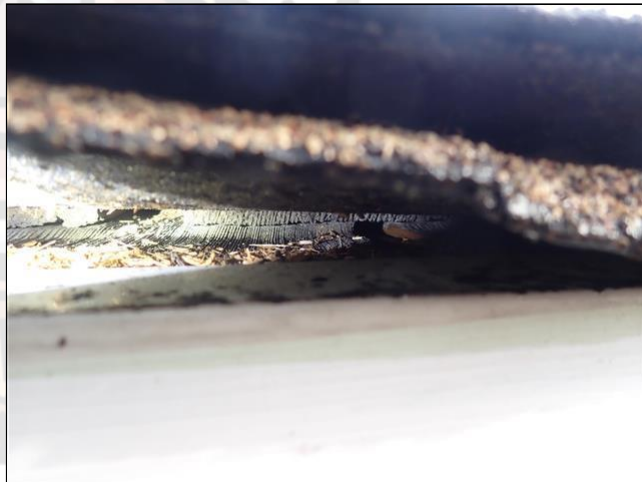
(4) Non-standard installation of sheet metal drip edge flashing was observed at roof. The underlayment (felt) does not lap over the drip edge flashing at the eaves and lap under the drip edge at the rakes. The current installation flashing can cause wood rot. We advise corrections with a licensed roofer as preventative maintenance. Note: This installation is considered acceptable in high wind areas.

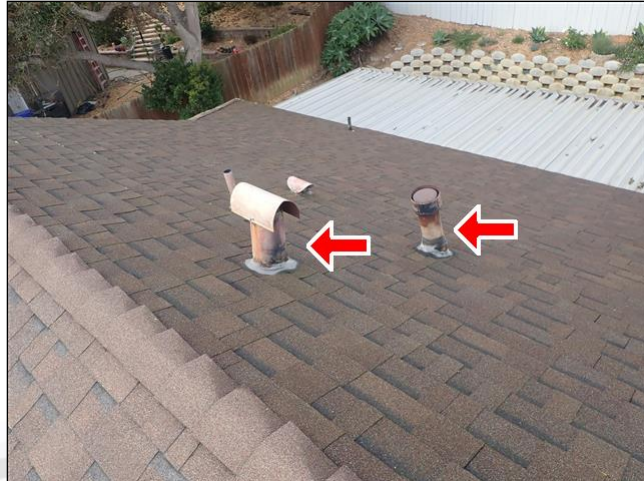
10.1 Picture

(5) Sheet metal flashings and ABS plumbing vents were not painted. Paint is required at the ABS vents and recommended at exterior sheet metal. We advise corrections with qualified painter.

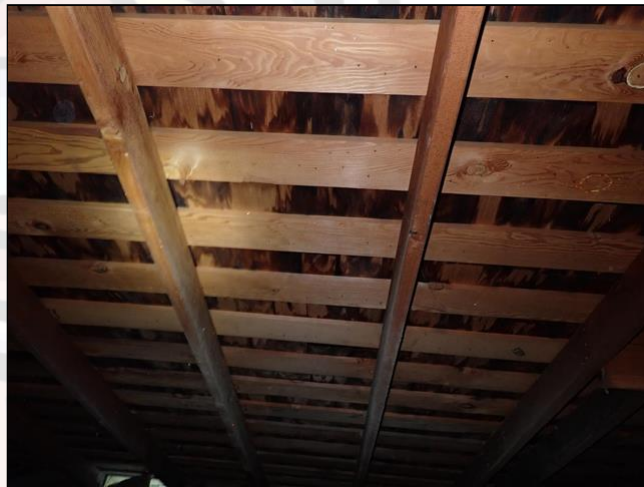
10.2 Picture

Note: No roof sheathing was present. For a future re-roof one major cost may be the need to re-sheet your entire roof deck with plywood, so that it is a solid wood deck, which is currently required by building standards. The original roof was installed over what's called an open-spaced deck. Typically it's composed of 1x6 deck boards spaced about 4-5 inches apart. These gaps don't work with some more modern materials, such as concrete tiles.

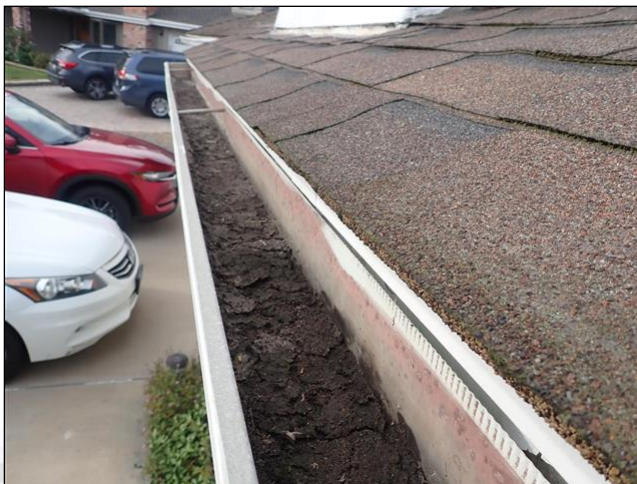
10.3 Picture

Gutters appear intact but due to the lack of recent rain, I am unable to determine if gutters leak at seams or drain properly.

Note: Gutters require cleaning. We recommend having them cleaned by a qualified person.

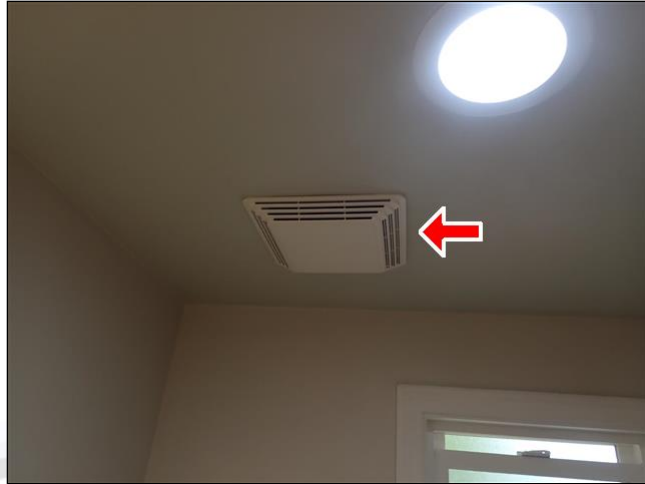
12.3 Picture

Exhaust fan(s) were tested and functional at time of inspection. (This is not an exhaustive test, and does not evaluate the performance or effectiveness of the vent(s))

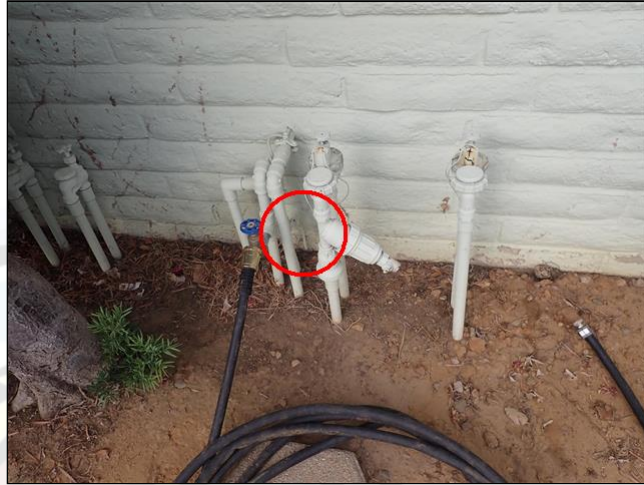
13.0 Picture

The main water shut-off valve is located at the right exterior of the house.

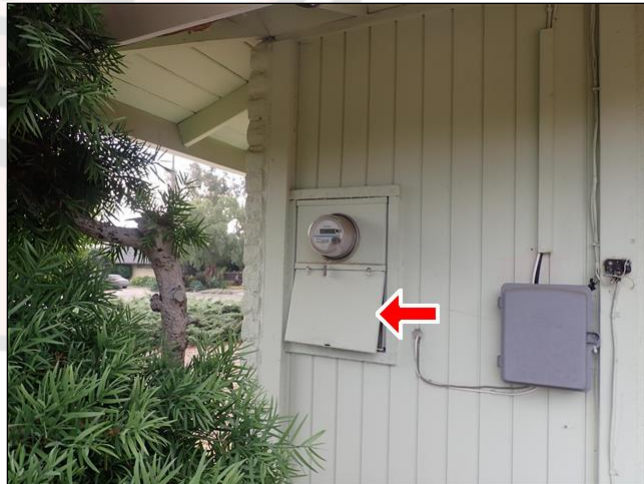
13.1 Picture

The main Electrical panel is located at the right exterior side of the house (facing front).

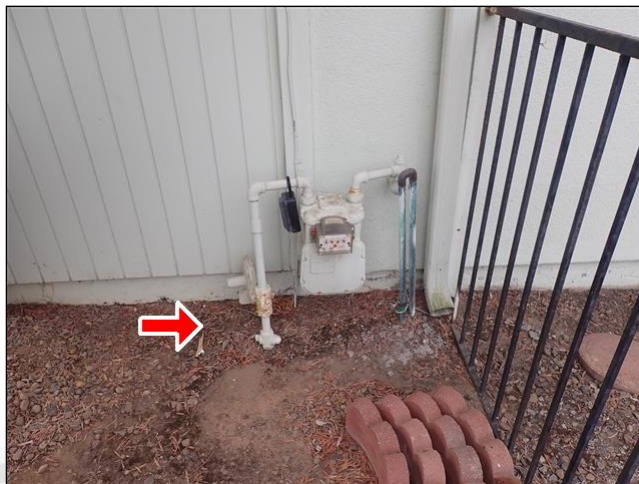
13.2 Picture

The main gas shut off valve is located at the gas meter at the right side of the house (facing front).
